PERFORMANCE OF REINFORCED ADOBE HOUSES IN PISCO, PERU EARTHQUAKE

A. San Bartolomé¹, D. Quiun¹, L. Zegarra¹

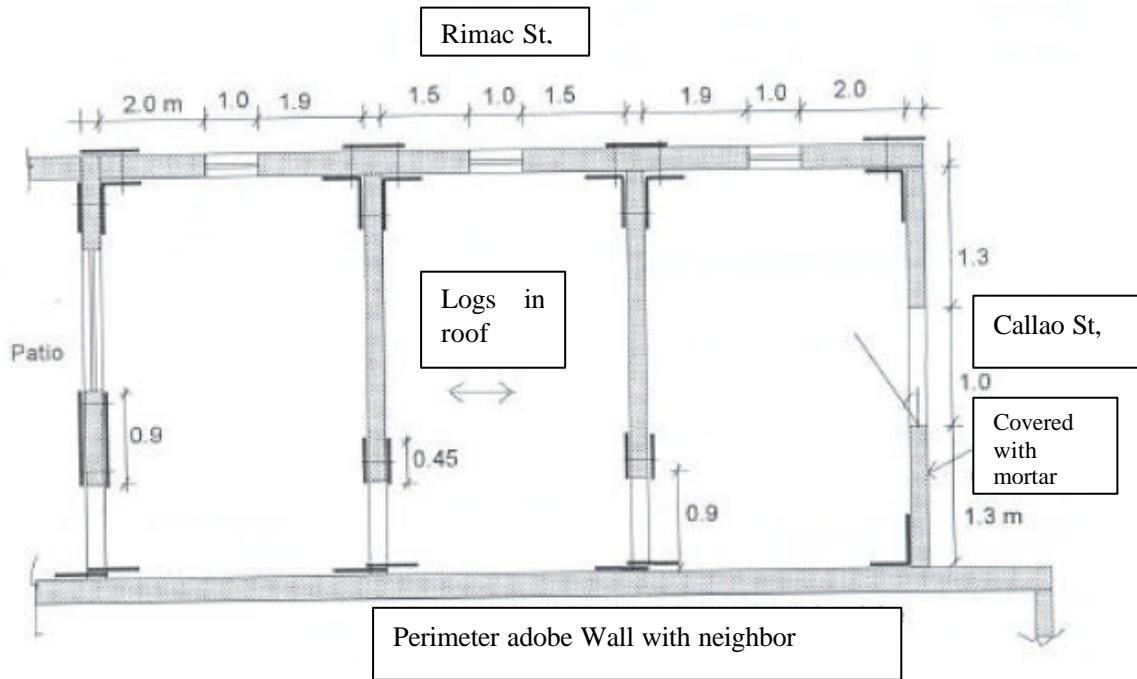
Figure 2. Adobe house in Guadalupe with location of vertical strips.

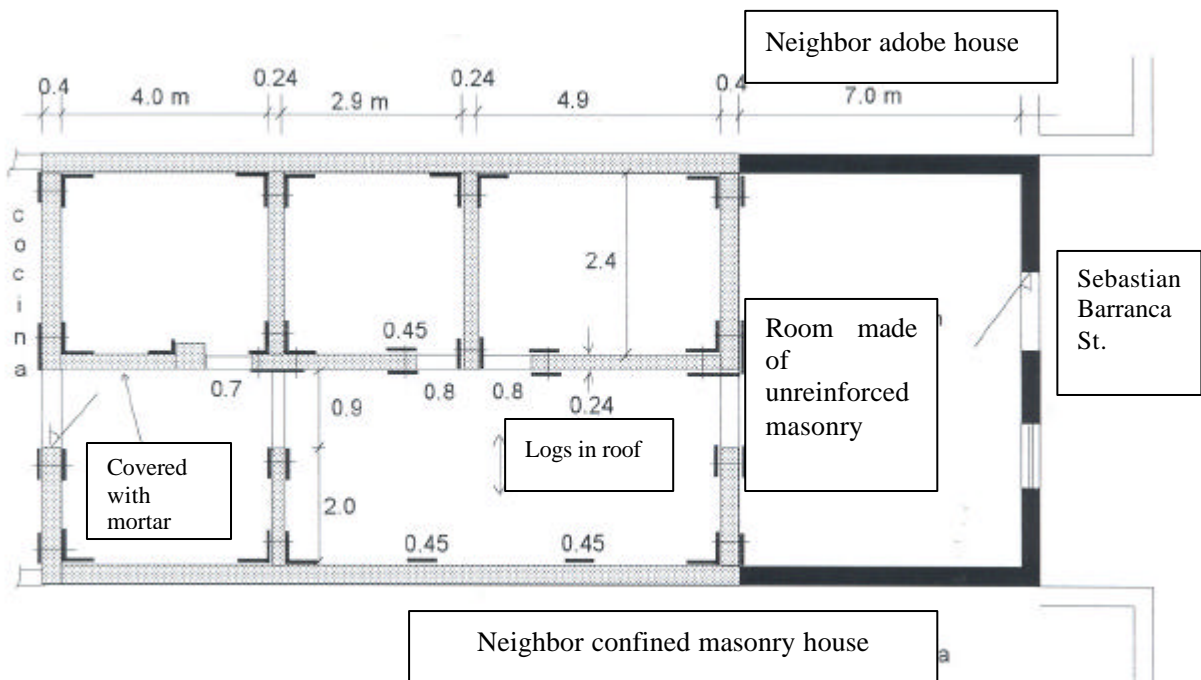
Figure 3. Adobe house in Pachacutec with location of vertical strips.

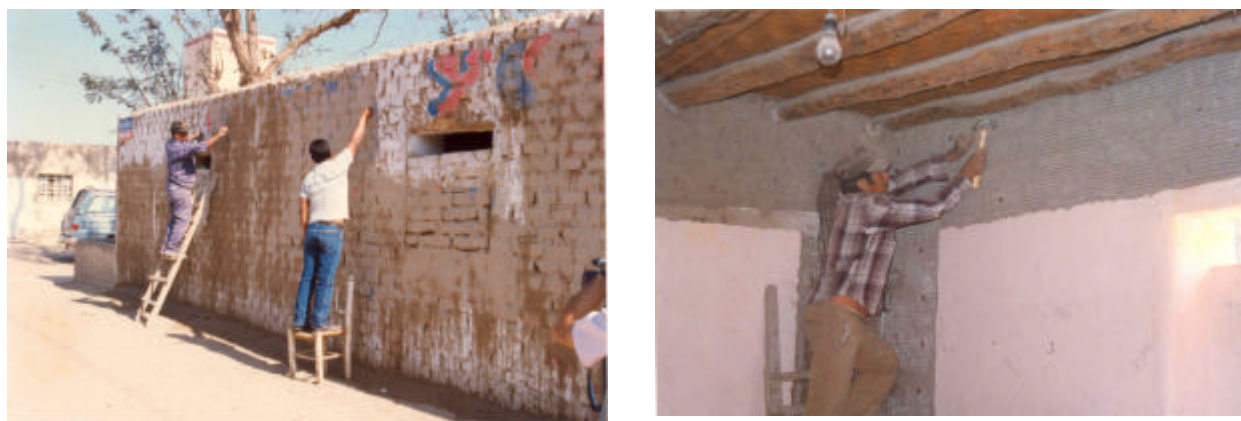
Figure 4. Adobe house in Guadalupe retrofitted in 1998 (left to right): marking horizontal strip at outside wall, nailing horizontal strip in inner side of wall.

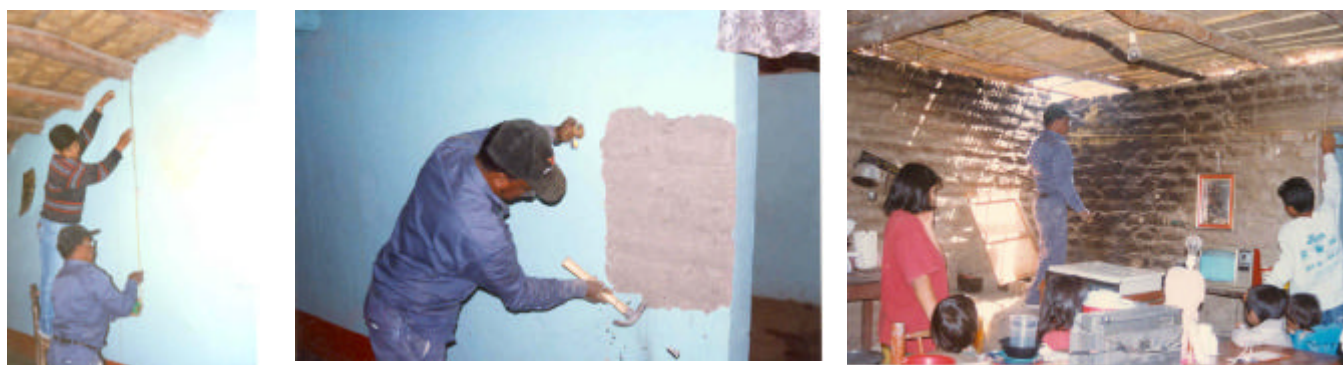
Figure 5. Adobe house in Pachacutec retrofitted in 1998 (left to right): marking vertical strip, removing existing covering, and marking horizontal strip.

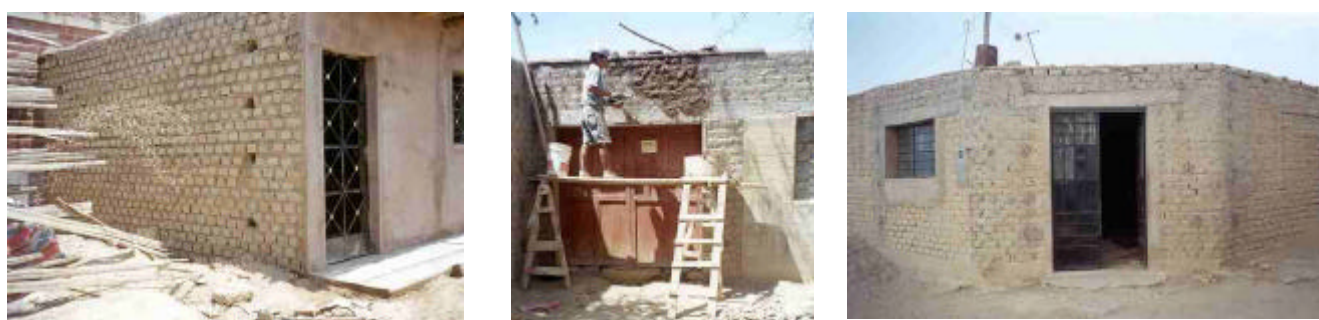
In the three demonstration houses in Ica, part of the wire mesh was left without covering while the other had the mortar covering. This part of the project was performed using the labor men that learned about the reinforcement technique in the two houses of the pilot project in Guadalupe and Pachacutec (figure 6).

Figure 6. Demonstration adobe houses in (left to right) Ica Central, Parcona and La Tinguña, during reinforcement in 1998.

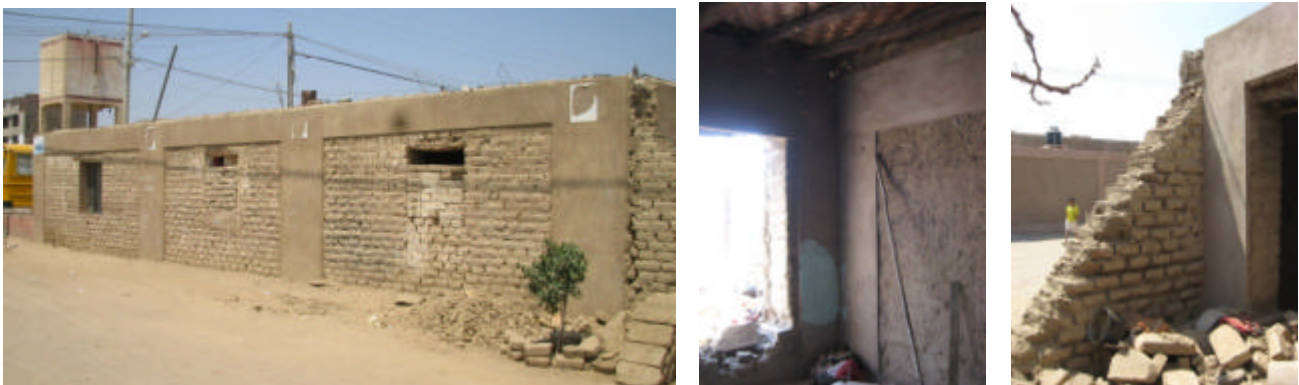
All 5 existing adobe houses retrofitted with strips of wire mesh in the affected area of Ica had an excellent seismic behavior without damage, while neighbor traditional constructions had massive failures, wall cracks and collapses. In figures 8 and 9 the reinforced adobe house of Guadalupe and unreinforced neighbor houses of traditional adobe, respectively, may be seen a few days after the event. Only the unreinforced wall of the patio, next to the reinforced area, collapsed by overturning; it was not reinforced due to lack of funds of the owner.

Figure 8. Guadalupe retrofitted adobe house without damage (except unreinforced patio wall)

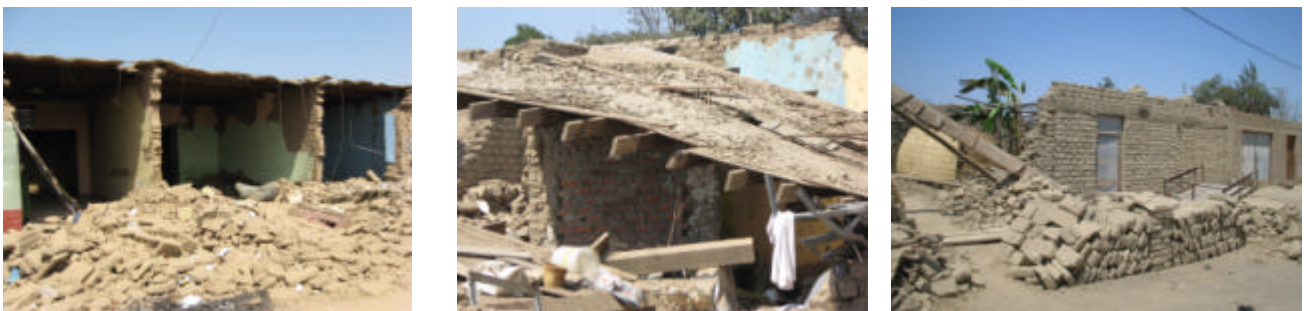
Figure 9. Other adobe houses with severe damage in Guadalupe

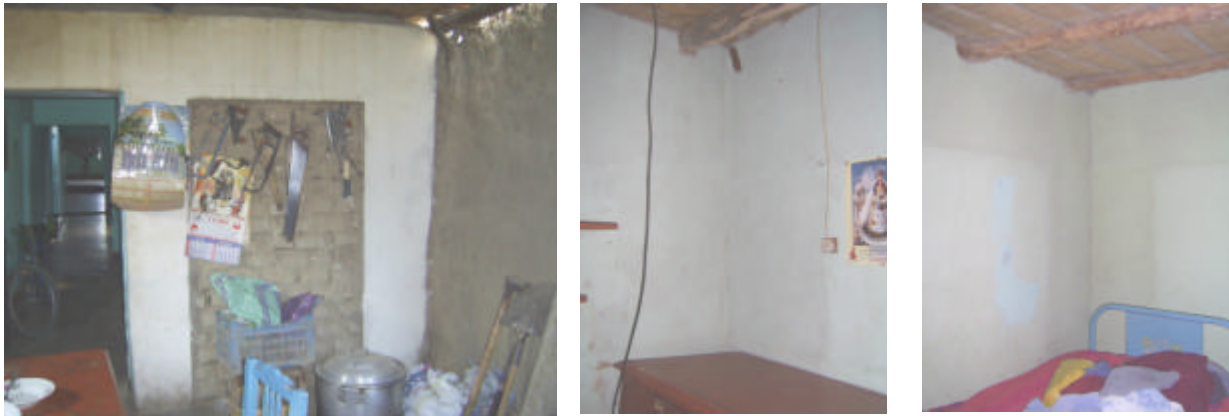
Figure 10. Pachacutec retrofitted adobe house without damage

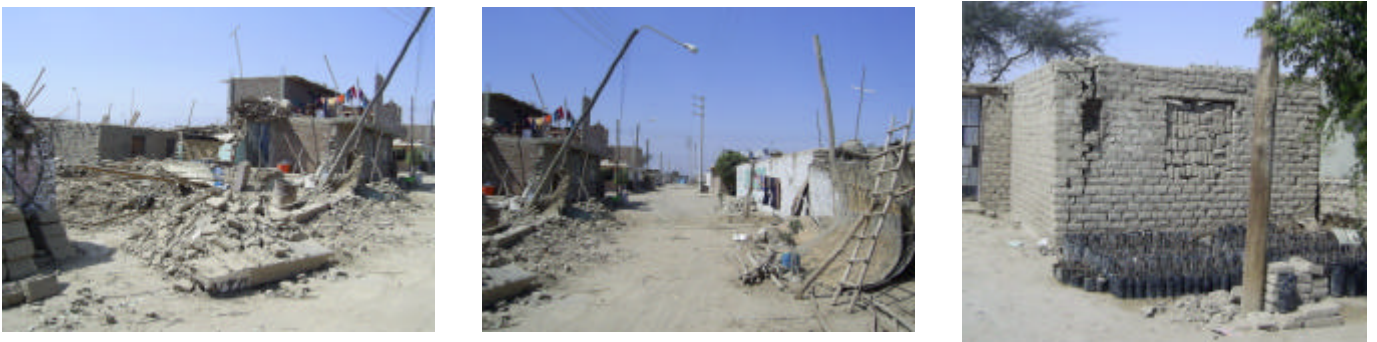
Figure 11. Traditional adobe houses with damage in Pachacutec

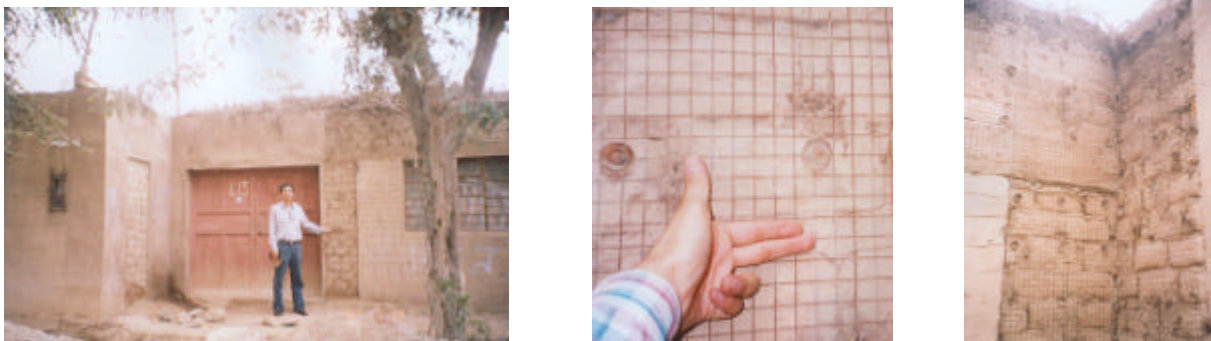
The Parcona house was partly reinforced, leaving a part of the outside mesh without covering and had no damage (fig. 12). This house is used as the station for the accelerograph, in which the foundation soil is sand lime (Tavera et. al., 2007). Other neighbor adobe houses had severe cracks and had to be demolished (fig.13).

Figure 12. Partly retrofitted Parcona house without damage

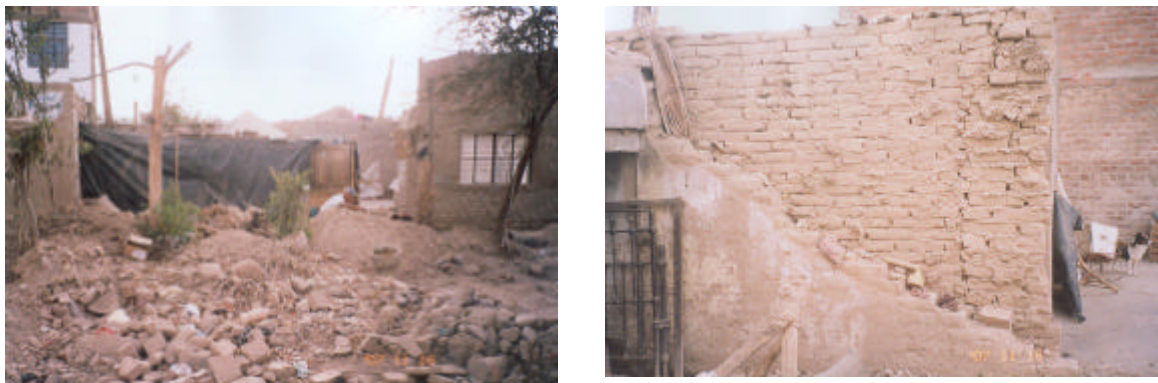
Figure 13. Demolished adobe walls in neighbor houses in Parcona

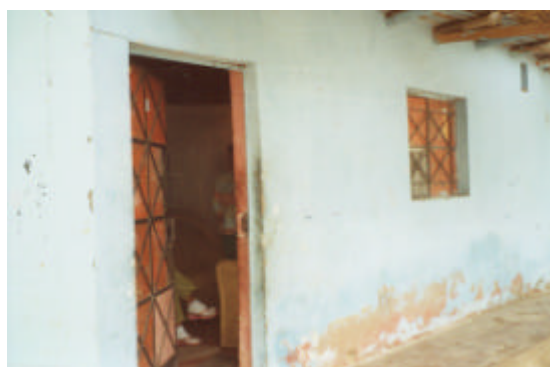
Figure 16. Partly retrofitted house in Ica Central had no damage
