SEISMIC BEHAVIOUR OF MASONRY CONSTRUCTIONS IN 2007 PISCO, PERU EARTHQUAKE

A. San Bartolomé¹ and D. Quiun¹

ABSTRACT :

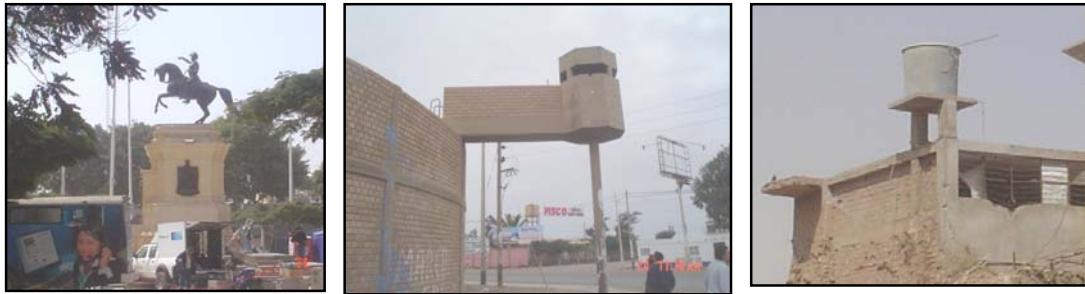
The Parcona and Ica2 stations are located on a sedimentary soil; in these stations the peak ground acceleration was 0.49g and 0.33g, respectively, associated to rupture R1, with much reduced values for rupture R2 and the rest of the record. For the most affected area in Pisco and Chincha, several facts evidence that the shock can be considered as a moderate one. The roads and electric poles were severely affected only in soft soils. Also, several structures did not suffer damage although their stability appears to be rather poor (Figure 3).

Figure 3. Evidences that the Pisco earthquake can be qualified as moderate.

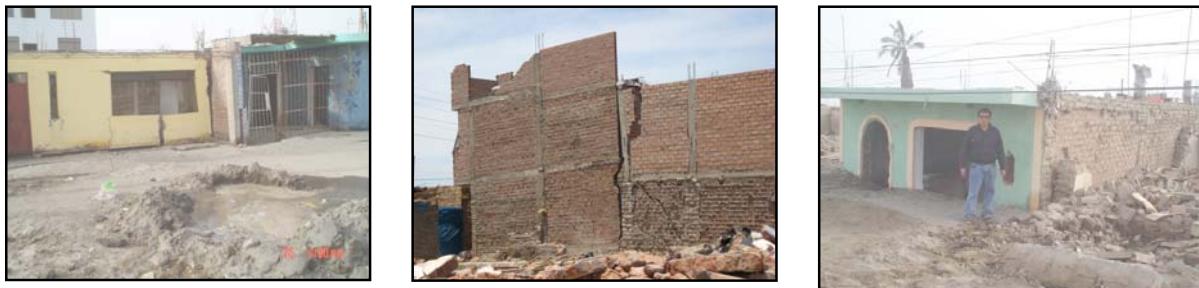
In the district of Tambo de Mora, province of Chincha, soil liquefaction produced several collapses of many adobe and masonry houses (1 to 3 stories high). This town has a very shallow water table, which during the earthquake provoked structural settlements (Figure 4). This severe damage demonstrates that in such soil conditions, the foundations should be very strong, economically unaffordable for the common people of the town. The first author of this paper suggested the major of Tambo de Mora to declare that area as an open museum, to show the effects of the soil liquefaction under non prepared structures.

Figure 4. Affected masonry houses in Tambo de Mora.

- 2) In the liquefaction area of Tambo de Mora, Chincha, it is recommended that no buildings should be built. Instead, a site museum is suggested, so that everybody visiting that town can see the destructive effects and understand such phenomena. Other potential areas of liquefaction should be identified and extreme precautions should be observed.

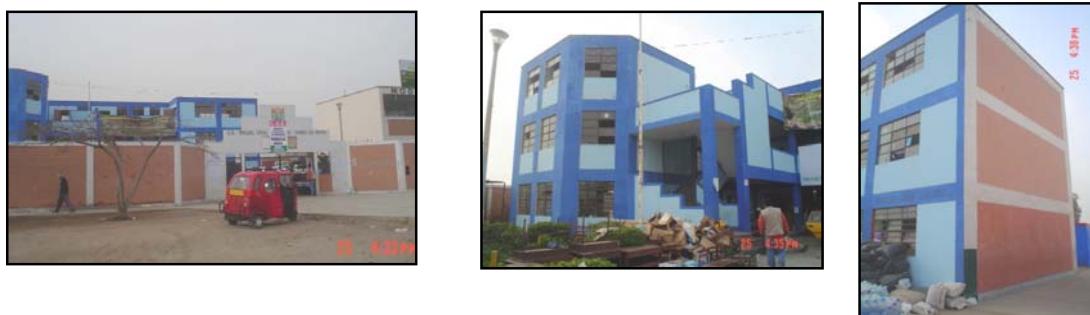
In Tambo de Mora, a few blocks away from the liquefaction area, a series of school buildings (Fig. 5), rests on a stable soil. The buildings of this school had only some small cracks in the masonry walls. Similar school buildings suffered damage during the earthquake of Nasca 1996 (Mw7.5, Muñoz et.al. 2004). It can be inferred that the accelerations in the stable soil area of Tambo de Mora must correspond to a moderate earthquake

Figure 5. School in Tambo de Mora, Chincha had slight damage.

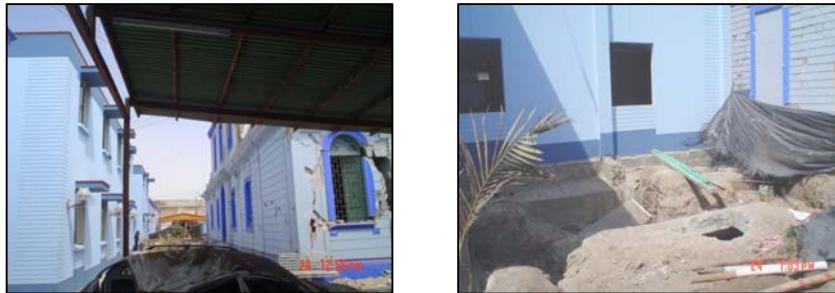
The masonry walls have brittle seismic behavior, with a drift of 1/800 diagonal cracks appear. So, for soft soil, a rigid foundation must be used. The Pisco hospital (figure 6) had a new block with RC foundation beams and had a good behavior, while old blocks without rigid foundations had heavy damage.

Figure 6. Pisco hospital with rigid foundation in new block (right)

- 3) The severe damage in the city of Pisco was observed mainly in soft soil conditions (sand with shallow water table). In such situations, it is recommended the use of rigid concrete foundations for any kind of buildings.

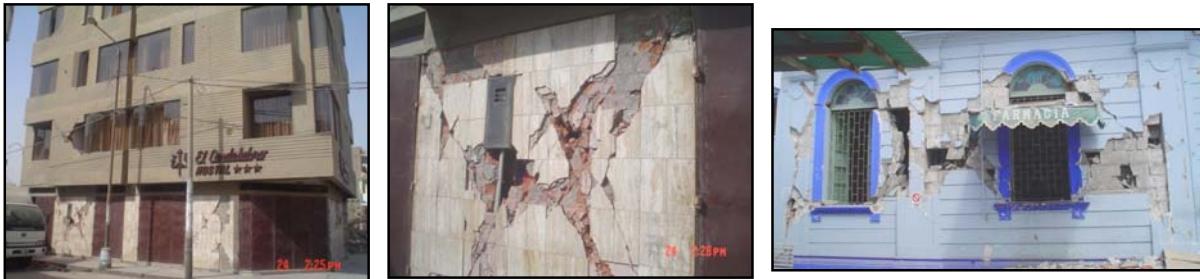
In the provinces of Pisco, Chincha and Ica it was observed that artisan made bricks, industrial tubular bricks and hollow concrete blocks, are popularly used for bearing and infill walls in buildings. According to the Peruvian Masonry Building Code (Norma E.070 in Spanish), in this seismic zone, artisan bricks may only be used for 1 or 2 stories. Also, the use of tubular bricks and hollow concrete blocks is forbidden in bearing walls because they crush at failure (Figure 7), losing drastically the resistance and rigidity of the walls (San Bartolomé 2007).

Figure 7. Inadequate masonry units used in Chincha, Pisco and Ica.

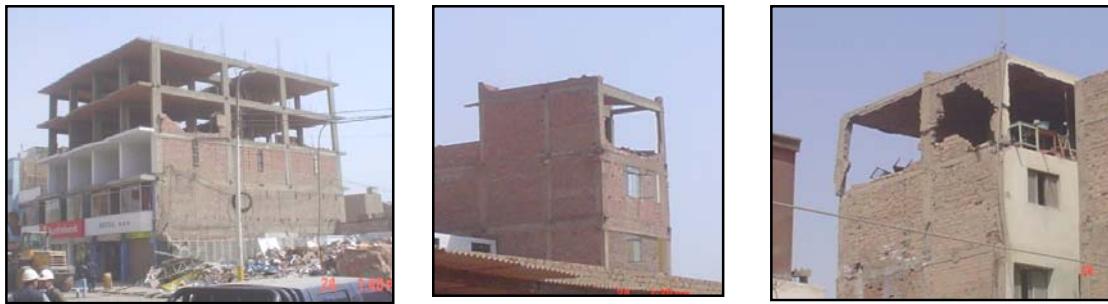
The way in which buildings in the affected area of Pisco and surroundings are constructed is hybrid, lying between confined masonry and framed RC with infill walls. This is a wrong structural conception, caused by informality construction and poor qualified hand labor. In such a hybrid typical wall, firstly the RC columns are cast, then the masonry wall is constructed, and finally, the RC roof slab and beams are cast. For this reason, hybrid masonry walls carry vertical load, but are not integrated with the concrete columns, as if a vertical smooth joint between wall and column existed.

Figure 8. Overturning of masonry walls in high stories due to out-of-plane seismic forces.

The Peruvian Masonry Code (SENCICO 2006) does not allow the construction type described. This code establishes that for a wall to be confined, the masonry wall has to be firstly built, and then the concrete of the columns can be poured. The connection between RC columns and masonry wall can to be toothed, or vertical with added connecting wires in the horizontal joints anchored in the columns. The construction sequence used in the Pisco buildings does not provide vertical support to the masonry wall under out-of-plane seismic forces. Therefore, after the earthquake, in many cases it could be observed that the masonry walls fell by overturning, especially in the higher stories (Figure 8), in which the acceleration are larger and the gravity load is less. A suggestion for such existing walls is to tie the masonry to the columns by using welded wire mesh.

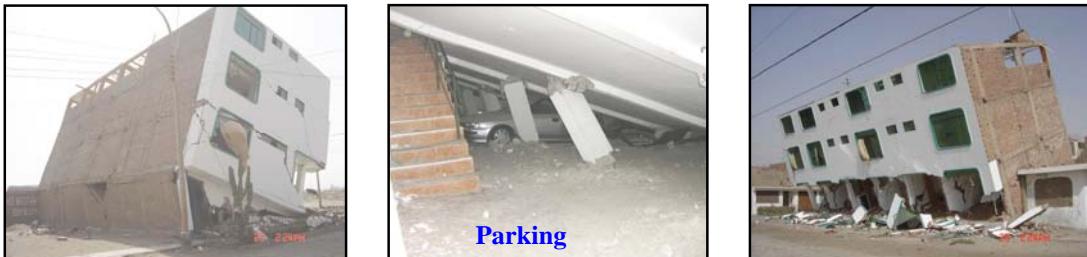
The soft story occurs due to a sudden change in rigidity between consecutive stories. In figure 9, along the shorter direction of the building, the first story walls did not continue for the use of parking area in the first floor, except the perimeter walls. The units of these walls are poor quality bricks, so the wall has low shear resistance. The walls at the building borders (corner) also produced an important torsional effect. Therefore, after the failure of the first floor walls in the short direction, the soft story problem developed and the whole building collapsed.

Figure 9. Soft story and torsion.

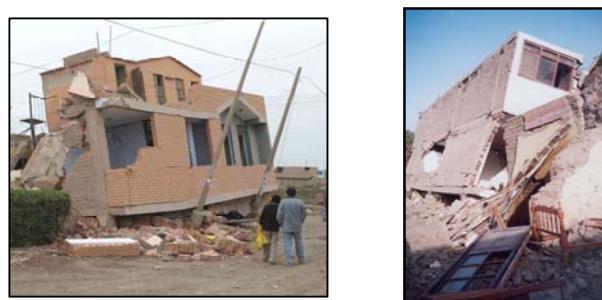
In the Peruvian Masonry Code (SENCICO 2006), buildings are required to have a minimum wall density in each direction, and, it must be verified that the provided wall resistance should be at least equal to the seismic shear force in the floor under analysis on a severe earthquake. The buildings shown in figure 10 were not only built with low quality bricks, but also had not enough wall density in the short direction as the Code requirement.

Figure 10. Low wall density

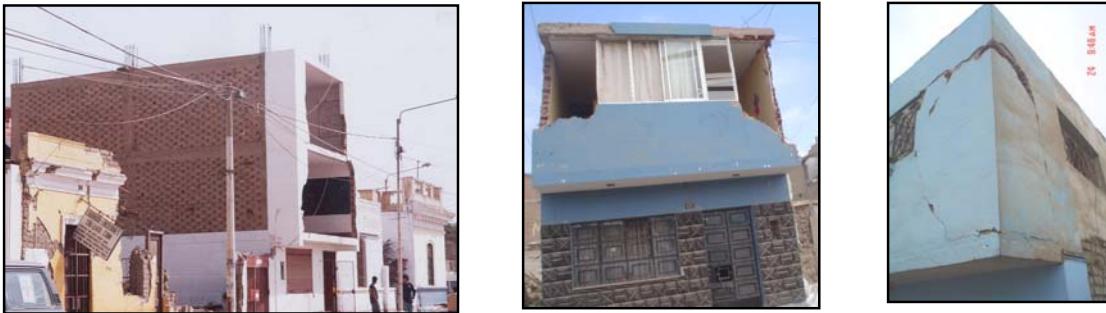
In some building façades, more area is added in the upper stories by cantilever slabs. Quite often, the walls in the room with part in cantilever are built using tubular bricks (called “pandereta” in Peru). Even though a toothed connection may exist with the orthogonal walls, it is not enough to resist the out-of-plane seismic forces, and fail by overturning (Figure 11) in a dangerous way, as they may fall over people getting out by the first floor. Such non bearing walls should be retrofitted, for example, using welded wire meshes.

Figure 11. Failure of cantilever facades by out-of-plane forces

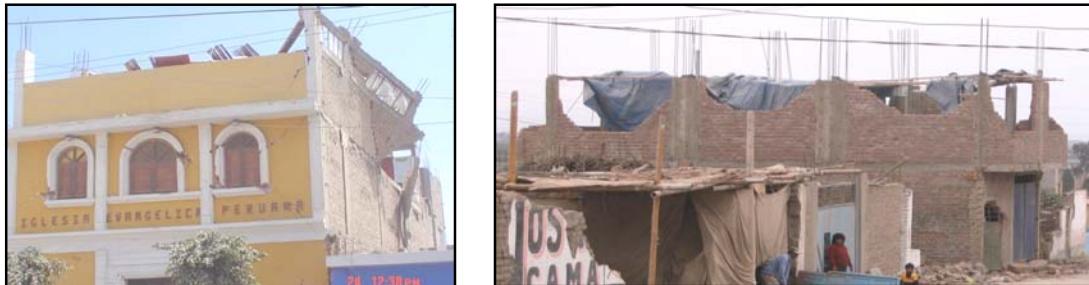
Several defects in the structural detailing could be observed in masonry buildings in the affected area. All of the following issues are mentioned in the Peruvian Masonry Code E.070 (SENCICO 2006) and were not complied: absence of diaphragms, missing collar beams, columns without continuity, beam-column joints without ties, and more. Some of the abovementioned situations are shown in figures 12 and 13.

Figure 12. Collapse of roofs and walls in buildings without rigid diaphragm

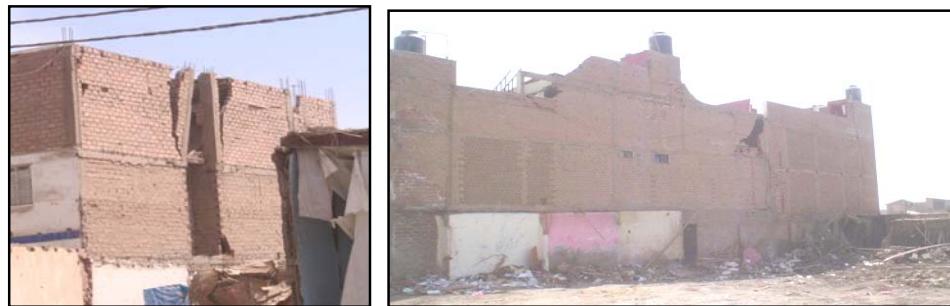
Figure 13. Walls without collar beam and column without continuity (left); bracing vertical columns too far apart each other (right); in both cases masonry failure is observed.

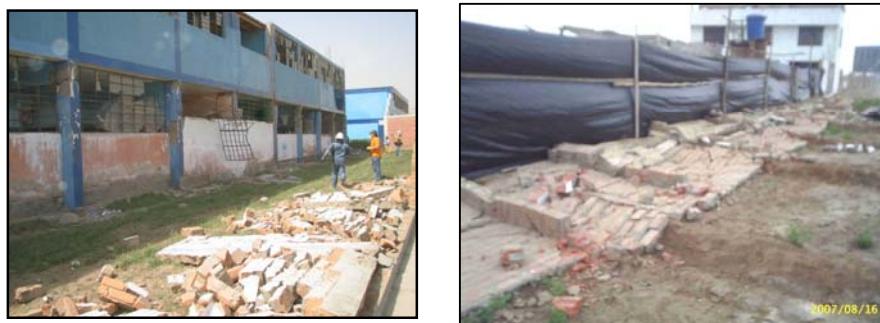
After the Pisco earthquake, in cities along the way between Lima and Ica, many perimeter walls and parapet walls collapsed by overturning, mostly due to lack of braces, or even when a rather small masonry wall was used as brace in the orthogonal direction. In several cases, the RC bracing columns collapsed together with the masonry wall due to lack of resistance, see Figures 14 and 15.

Figure 14. Perimeter walls collapsed by overturning. Masonry Piers are not enough.

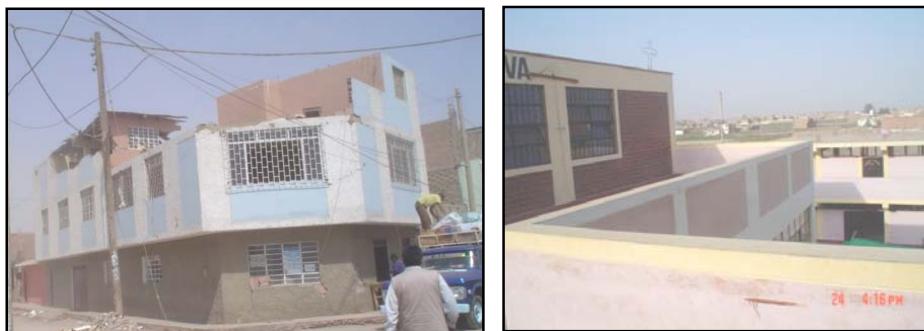
Figure 15. Parapet wall without bracing collapsed (left) and other adequately braced undamaged, both located on the third floor of their respective buildings, Pisco.
