REPAIR AND SEISMIC RETROFITTING OF HOSPITAL AND SCHOOL BUILDINGS IN PERU

SUMMARY

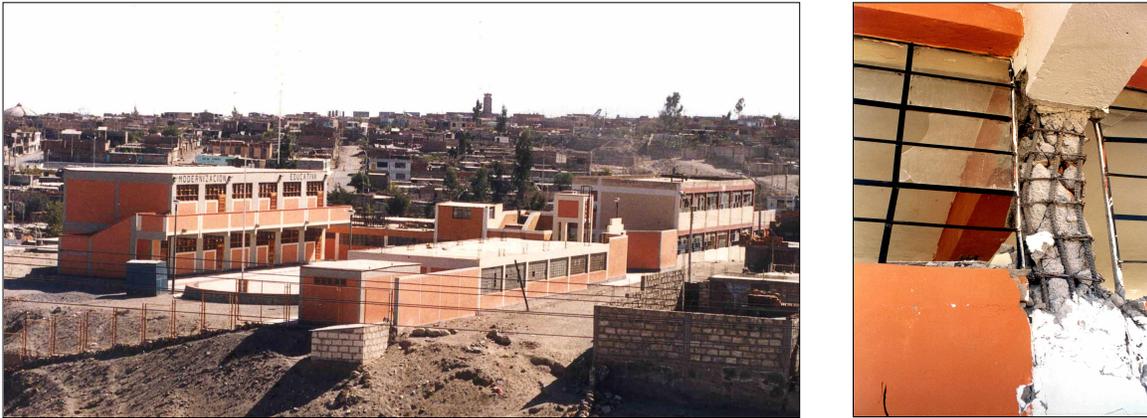
The “Casimiro Cuadros” school in Arequipa features building blocks constructed in different years, using different codes and design criteria, as well as a visible difference in quality of construction. At this site, the seismic base movement in the 2001 earthquake must have been similar for all the blocks; however, each block had a distinct behavior (fig. 1). The old blocks had flexible systems and showed the short column failure, with so much damage that the blocks had to be demolished. On the other hand, the rigid block, designed and built according to the 1997 seismic code criteria, was undamaged. What happened in the “Casimiro Cuadros” school is a good example on what could be observed in other schools buildings in the affected zone: flexible traditional blocks with shear failure in columns due to the short column problem, and rigid new blocks without any damage.

Fig. 1. “Casimiro Cuadros” school in Arequipa: old and new blocks (left) and short column failure in old block (right).

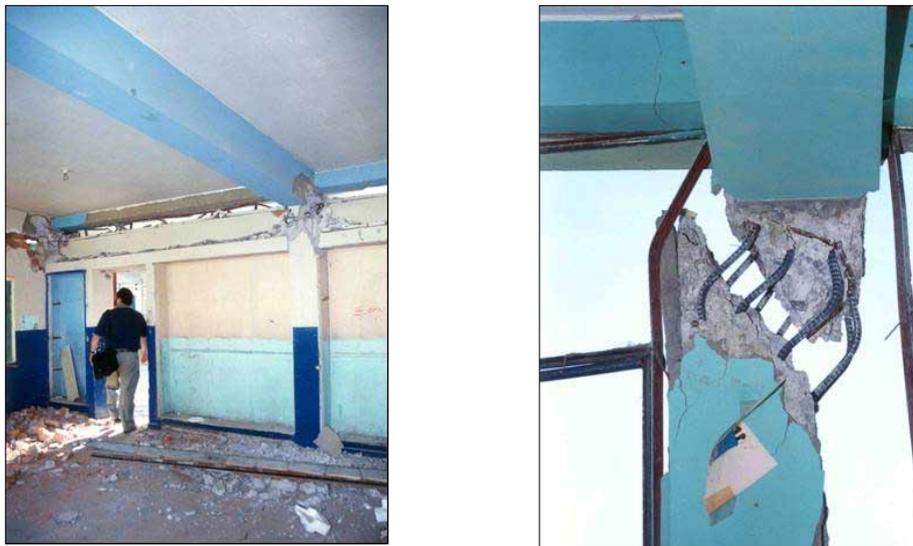
In the city of Moquegua, the “Angela Barrios” school (an older type) was one of the most affected. At the corner block, the interior columns failed due to the short column effect (fig. 2, left), losing more than 0.3m height; then, the roof fell inclined producing the failure of the exterior columns (fig. 2, right). This school is located in a sloping area, and the affected block was elevated between 2 to 4 meters above natural terrain. It is probable that a foundation problem and a bad quality of the construction may have increased the natural vulnerability of this structural system.

Fig. 2. “Angela Barrios” school in Moquegua: interior column general failure (left), and exterior column failure (right).

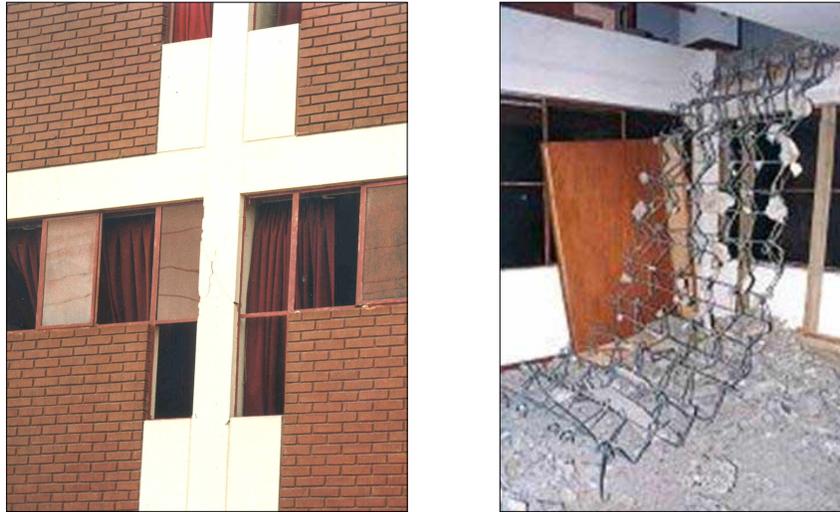
The “San Agustín” National University in Arequipa had also several buildings damaged due to their flexibility, with short column effect present in several blocks. In the Electronics Engineering block it was intended to avoid the short column effect by using a window between the column and the walls; however, the poor rigidity of the building and the window rigid frame were enough to produce the shear failure (fig. 3, left). Another collapsed structure was the first floor staircase of the main library (fig. 3, right).

Fig. 3. “San Agustín” National University in Arequipa: short column typical failure (left), and library staircase collapse (right).

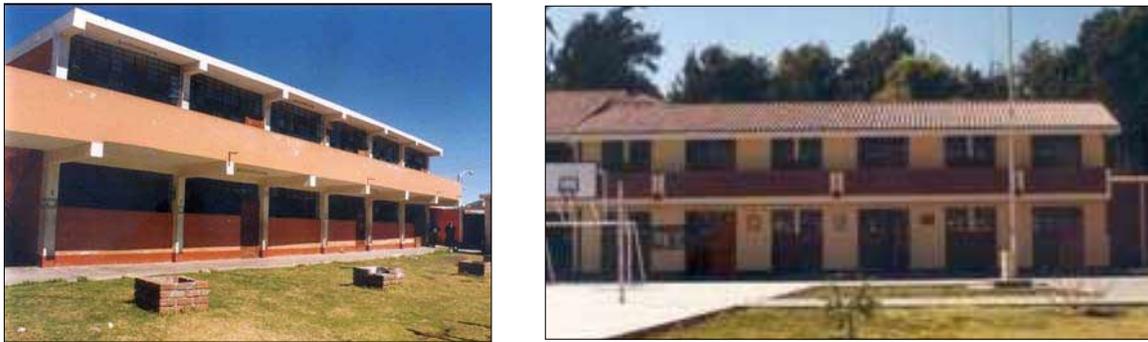
Some older school blocks in the affected area had little damage, due to the great rigidity provided by the infill walls in the frames. A traditional school building without damage (fig. 4, left) has its rear facade coinciding with the property limit, which was closed up with an infill wall all long. Also, the new school buildings in the affected region, designed and constructed according to the 1997 seismic code, had no damage, neither structural, nor in windows, doors, or infill masonry walls (fig. 4, right). The structural seismic resistant system of these blocks consists of masonry bearing walls in the transverse direction and strong concrete columns in the longitudinal direction.

Fig. 4. Traditional school without damage due to infill wall at rear facade (left), and new school buildings featuring strong columns in the longitudinal direction without any damage (right).

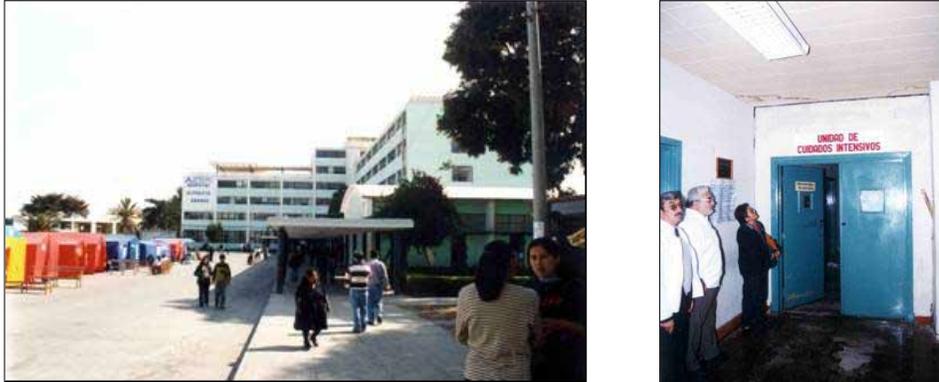
the 3 six-story buildings were evacuated and emergency constructions had to be installed (fig. 5, left); besides the non-structural walls, the sanitary installations were also damaged (fig. 5, right).

Fig. 5. “Hipólito Unanue” hospital in Tacna had damage to non-structural walls and sanitary installations.

In the affected buildings of “Hipólito Unanue” Hospital in the city of Tacna in southern Peru, the retrofitting works have begun; however, as the hospital is nearly 50 years old, the electrical and sanitary installations were found to be deteriorated and the assigned budget had to be increased. The buildings are now partially on service.

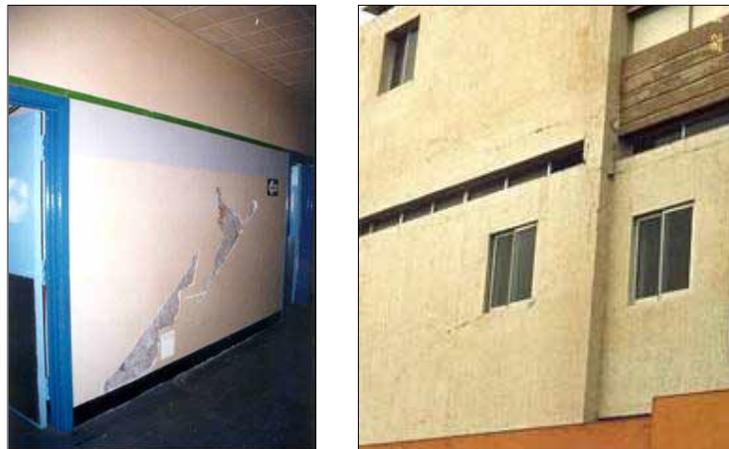
All important hospitals in the affected area were built several decades ago, without the safety criteria and engineering knowledge of today. The structural system of these buildings consists of reinforced concrete frames, mainly thought on vertical loads; therefore, they lack of adequate resistance, ductility and rigidity for seismic forces. However, in these buildings in both directions, there are a large amount of non-structural walls attached to the main structure. During the earthquake, these walls reduced the lateral displacements and dissipated energy (fig. 6); by that way, they protected the vertical load carrying system.

Fig. 6. Non-structural walls controlled lateral displacements and dissipated energy during the earthquake in hospitals: Arequipa (left) and Arica (right).

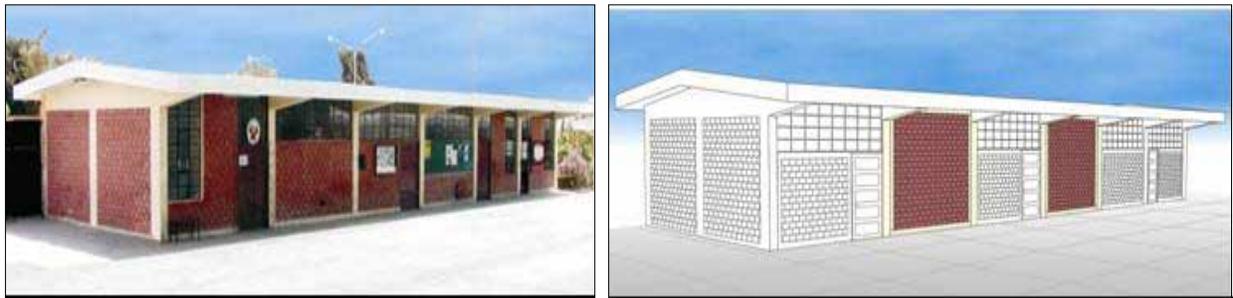
Fig. 8. One story school building damaged after the 2001 earthquake (left) and projected retrofitting in the longitudinal direction (right).

For one-story buildings, usually masonry walls were included, along with concrete confinement columns of the existing frames and new beams on the roof. In figure 8 an affected one-story building and the retrofitted structural system are presented.

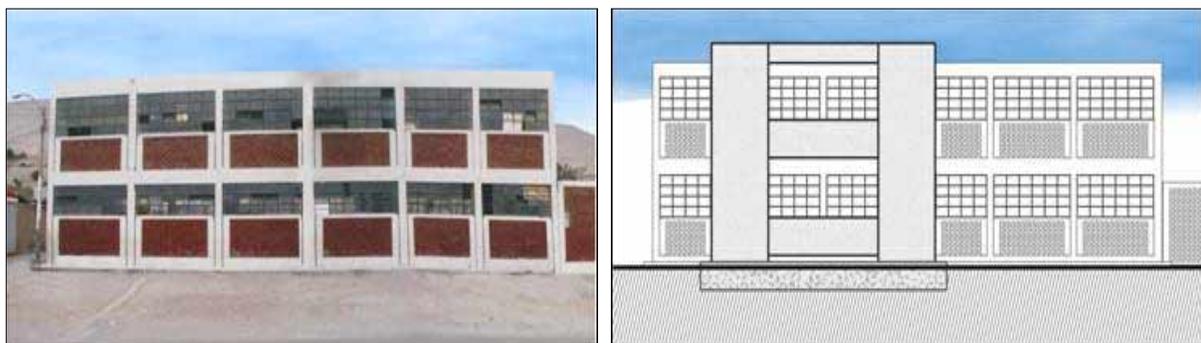
Fig. 9. Two-story school building damaged after the 2001 earthquake (left) and projected retrofitting in the longitudinal direction (right).

In case of two through four-story buildings, the retrofitting included small concrete walls and coupling beams. The concrete walls generally were constructed including the existing frame columns; the coupling beams have large inertia and were located inverted over the floor slab, as architectural parapets. In figure 9 an affected two-story building and the retrofitted structural system are presented.

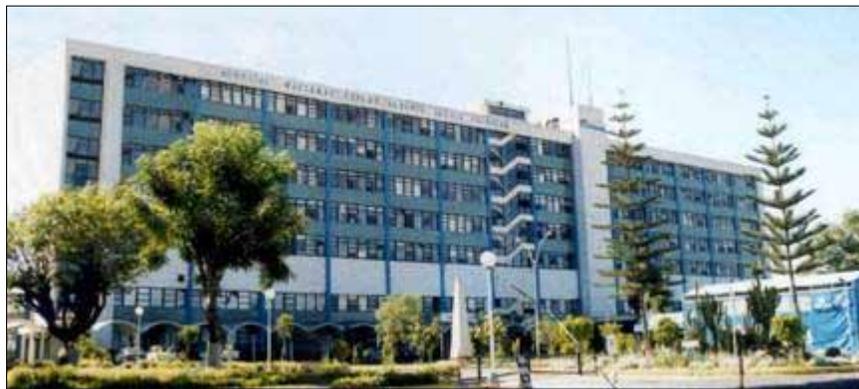
The tallest hospital building is dedicated to hospitalization rooms and consulting areas, with 7 stories and a gross constructed area of 14 000 m². It was originally divided into two blocks by a 0.05 m central joint. The structure of this building was mainly conceived to support vertical loads, with reinforced concrete frames perpendicular to the facades, to support the floor slabs; also, there are some concrete walls in the elevator and staircase boxes (fig. 10).

Fig. 10. Main building of the Arequipa hospital before the retrofitting.
