PERFORMANCE OF REINFORCED ADOBE HOUSES IN PISCO, PERU EARTHQUAKE

A. San Bartolomé¹, D. Quiun¹, L. Zegarra¹

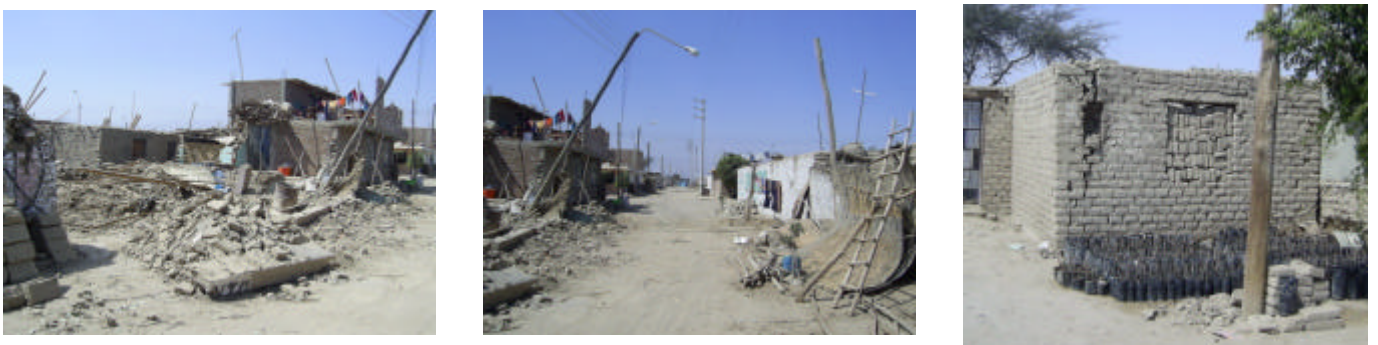
Figure 11. Traditional adobe houses with damage in Pachacutec
