## SEISMIC BEHAVIOUR OF ADOBE HOUSES IN PISCO, PERU EARTHQUAKE

A. San Bartolomé<sup>1</sup> and D. Quiun<sup>1</sup>

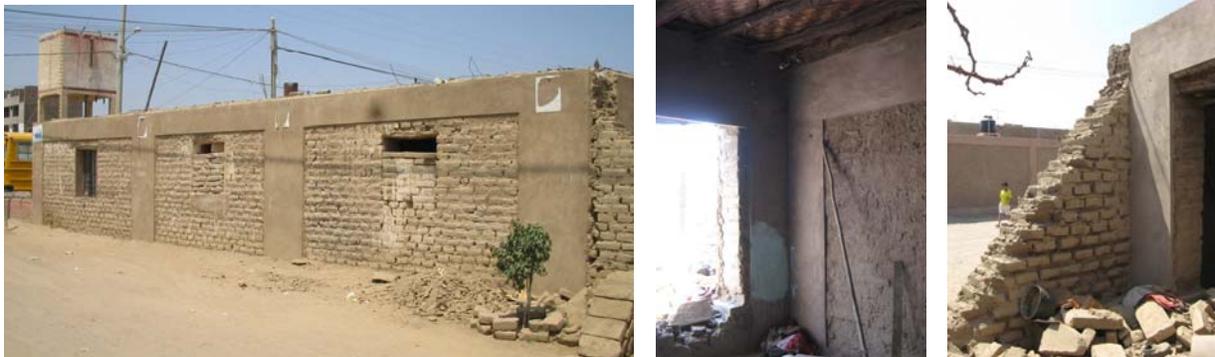
All 5 existing adobe houses retrofitted with strips of wire mesh in the affected area of Ica had an excellent seismic behavior without damage, while neighbor traditional constructions had massive failures, wall cracks and collapses. In figures 8 and 9 the reinforced adobe house of Guadalupe and unreinforced neighbor houses of traditional adobe, respectively, may be seen a few days after the event. Only the unreinforced wall of the patio, next to the reinforced area, collapsed by overturning; it was not reinforced due to lack of funds of the owner.

Figure 8. Guadalupe retrofitted adobe house without damage (except unreinforced patio wall)

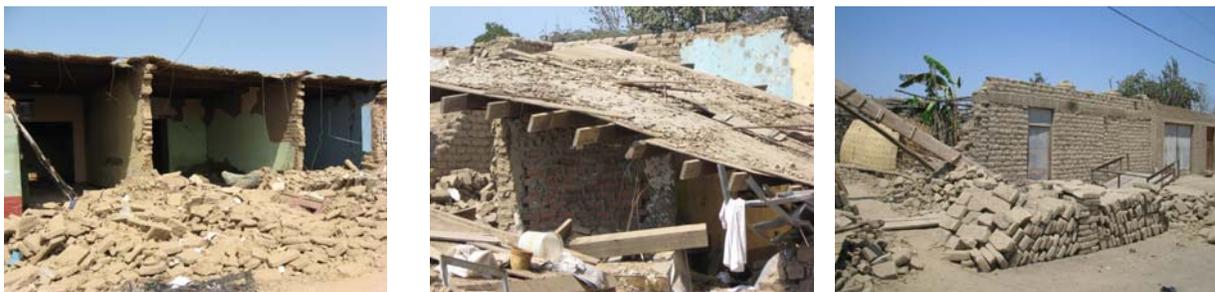
Figure 9. Other adobe houses with severe damage in Guadalupe

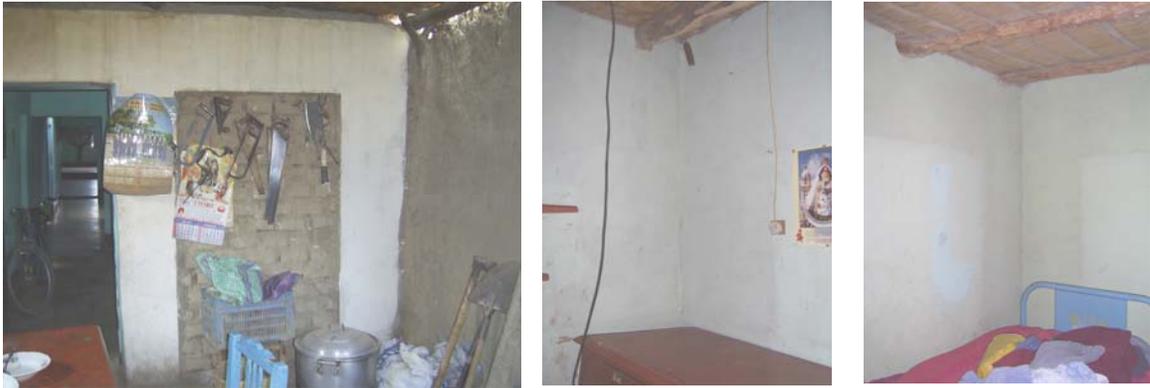
In figures 10 and 11 the reinforced adobe house of Pachacutec without damage and some unreinforced neighbor houses with damage, respectively, are shown a few days after the event.

Figure 10. Pachacutec retrofitted adobe house without damage

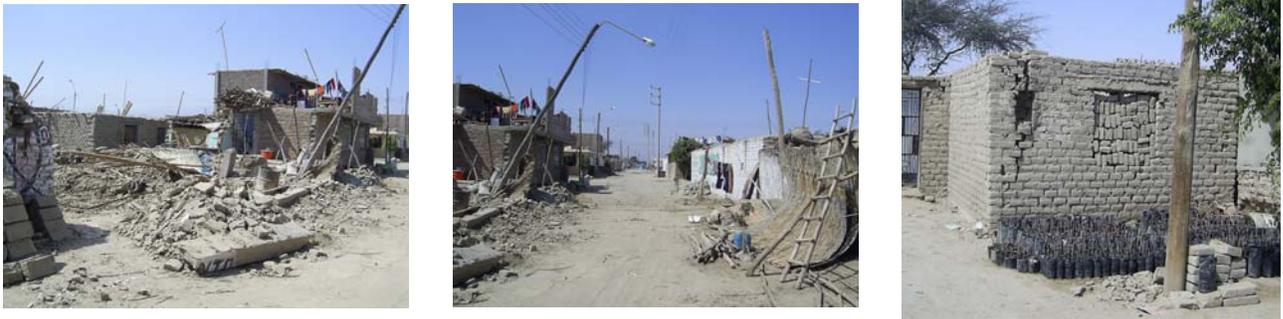
Figure 11. Traditional adobe houses with damage in Pachacutec

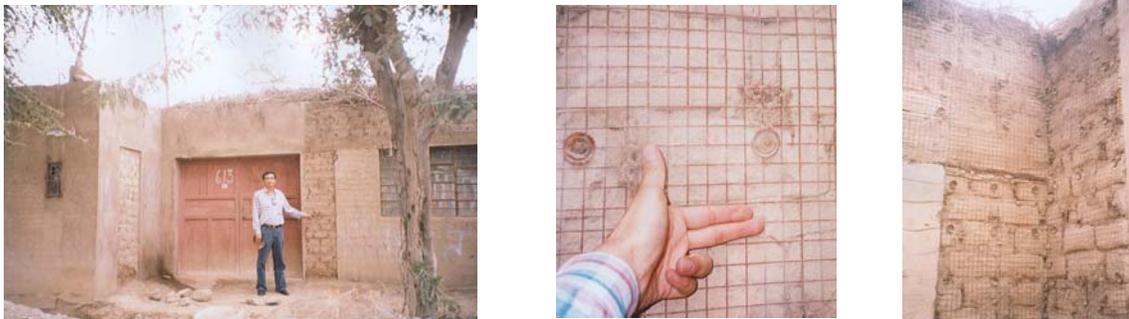
The Parcona house was partly reinforced, leaving a part of the outside mesh without covering and had no damage (fig. 12). This house is used as the station for the accelerograph, in which the foundation soil is sand lime (Tavera et. al., 2007). Other neighbor adobe houses had severe cracks and had to be demolished (fig.13).

Figure 12. Partly retrofitted Parcona house without damage

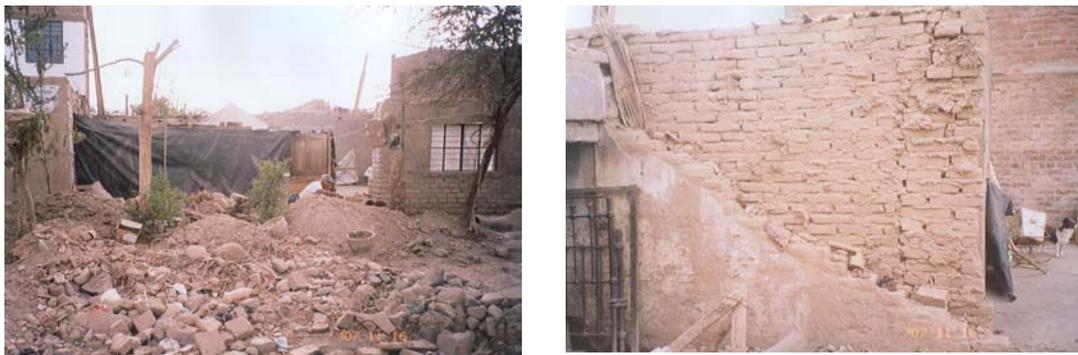
Figure 13. Demolished adobe walls in neighbor houses in Parcona

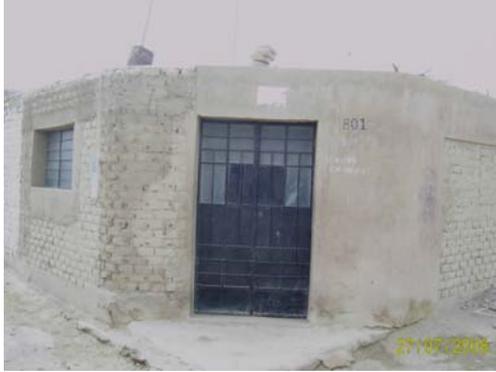
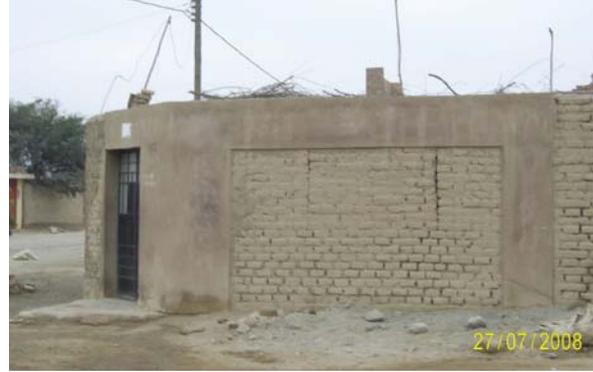
In La Tinguiña, the demonstration adobe house was partly reinforced only in the front room (fig. 14). To the left side in fig. 14 it is observed that the wire mesh has not mortar covering. The back room without any reinforcement had important cracks (fig.15). Similarly, the house in Ica Central was not affected by the earthquake (fig. 16), while other neighbor adobe houses had severe cracks.

Figure 14. Partly retrofitted house in La Tinguiña had no damage.

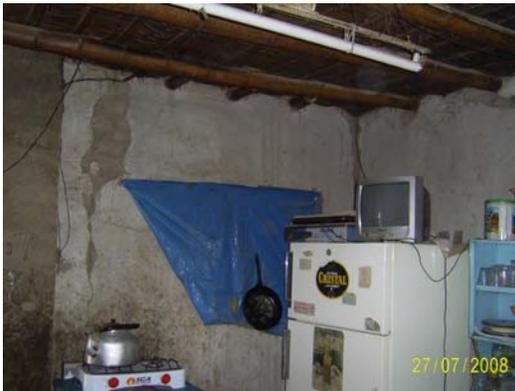
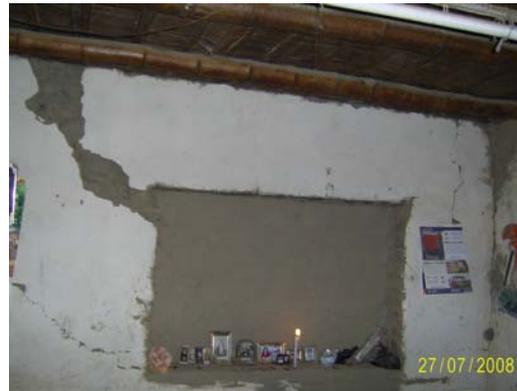
Figure 15. Non reinforced back room of the house in La Tinguiña had cracks.

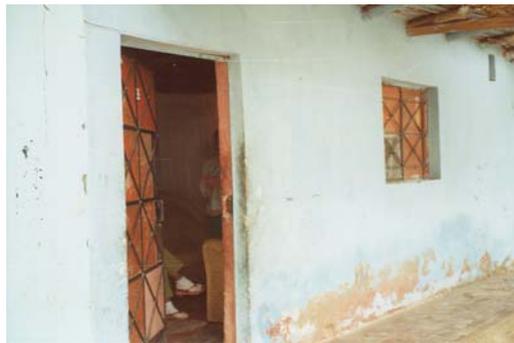
Figure 16. Partly retrofitted house in Ica Central had no damage
