SEISMIC BEHAVIOUR OF MASONRY CONSTRUCTIONS IN 2007 PISCO, PERU EARTHQUAKE

A. San Bartolomé¹ and D. Quiun¹

ABSTRACT :

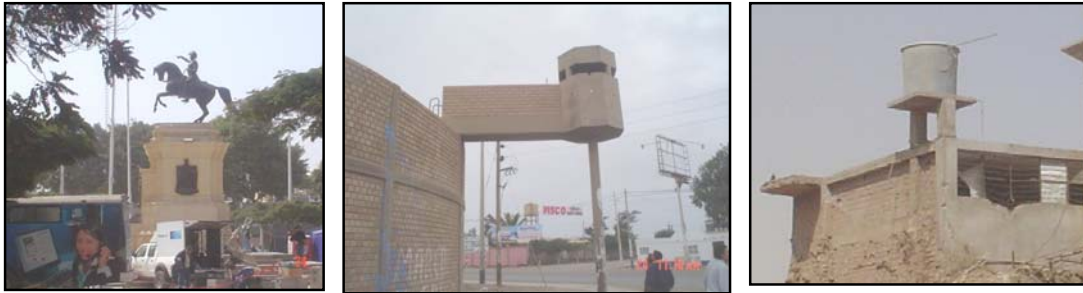
It can be said that this earthquake can be considered a moderate one, because other well done structures did not suffer any damage. Previously to this earthquake, a new Masonry Building Code was enforced in Peru

Figure 3. Evidences that the Pisco earthquake can be qualified as moderate.

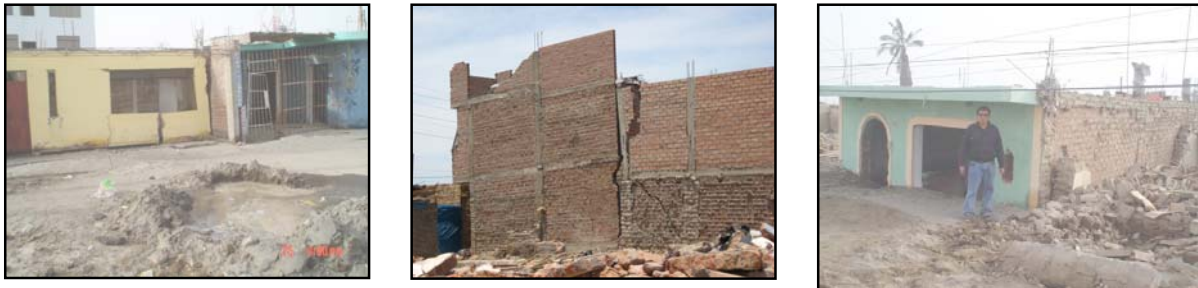
In the district of Tambo de Mora, province of Chincha, soil liquefaction produced several collapses of many adobe and masonry houses (1 to 3 stories high). This town has a very shallow water table, which during the earthquake provoked structural settlements (Figure 4). This severe damage demonstrates that in such soil conditions, the foundations should be very strong, economically unaffordable for the common people of the town. The first author of this paper suggested the major of Tambo de Mora to declare that area as an open museum, to show the effects of the soil liquefaction under non prepared structures.

Figure 4. Affected masonry houses in Tambo de Mora.

- 2) In the liquefaction area of Tambo de Mora, Chincha, it is recommended that no buildings should be built. Instead, a site museum is suggested, so that everybody visiting that town can see the destructive effects and understand such phenomena. Other potential areas of liquefaction should be identified and extreme precautions should be observed.

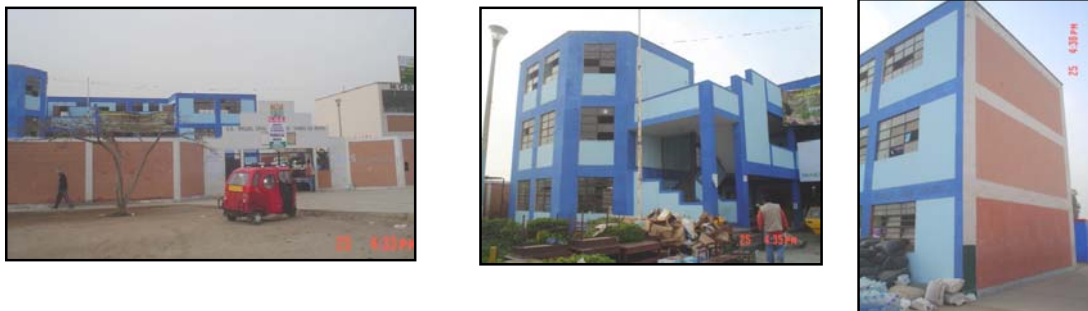
In Tambo de Mora, a few blocks away from the liquefaction area, a series of school buildings (Fig. 5), rests on a stable soil. The buildings of this school had only some small cracks in the masonry walls. Similar school buildings suffered damage during the earthquake of Nasca 1996 (Mw7.5, Muñoz et.al. 2004). It can be inferred that the accelerations in the stable soil area of Tambo de Mora must correspond to a moderate earthquake

Figure 5. School in Tambo de Mora, Chincha had slight damage.

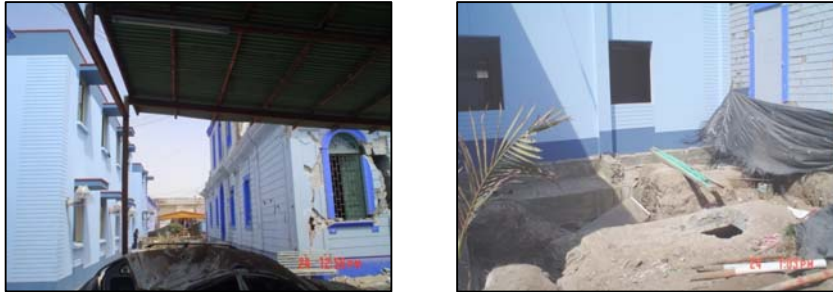
The masonry walls have brittle seismic behavior, with a drift of 1/800 diagonal cracks appear. So, for soft soil, a rigid foundation must be used. The Pisco hospital (figure 6) had a new block with RC foundation beams and had a good behavior, while old blocks without rigid foundations had heavy damage.

Figure 6. Pisco hospital with rigid foundation in new block (right)

- 3) The severe damage in the city of Pisco was observed mainly in soft soil conditions (sand with shallow water table). In such situations, it is recommended the use of rigid concrete foundations for any kind of buildings.

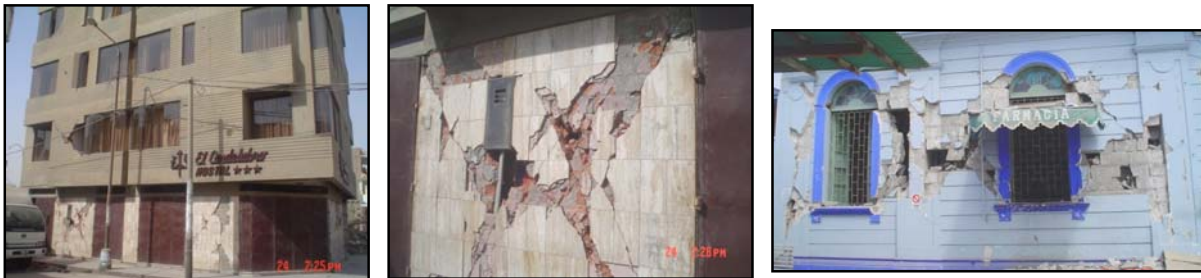
In the provinces of Pisco, Chincha and Ica it was observed that artisan made bricks, industrial tubular bricks and hollow concrete blocks, are popularly used for bearing and infill walls in buildings. According to the Peruvian Masonry Building Code (Norma E.070 in Spanish), in this seismic zone, artisan bricks may only be used for 1 or 2 stories. Also, the use of tubular bricks and hollow concrete blocks is forbidden in bearing walls because they crush at failure (Figure 7), losing drastically the resistance and rigidity of the walls (San Bartolomé 2007).

Figure 7. Inadequate masonry units used in Chincha, Pisco and Ica.

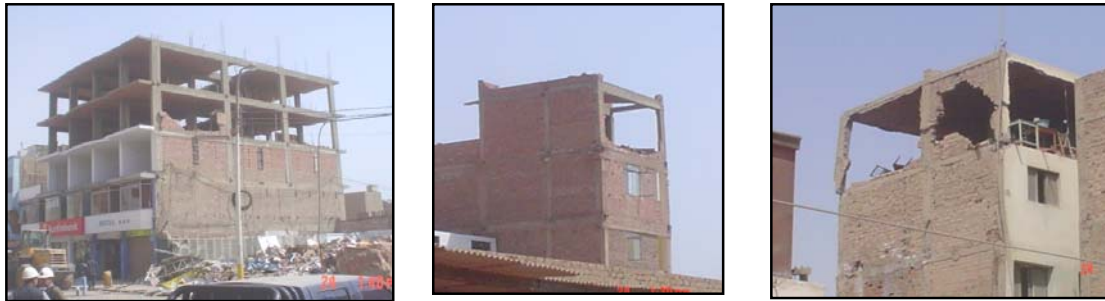
The way in which buildings in the affected area of Pisco and surroundings are constructed is hybrid, lying between confined masonry and framed RC with infill walls. This is a wrong structural conception, caused by informality construction and poor qualified hand labor. In such a hybrid typical wall, firstly the RC columns are cast, then the masonry wall is constructed, and finally, the RC roof slab and beams are cast. For this reason, hybrid masonry walls carry vertical load, but are not integrated with the concrete columns, as if a vertical smooth joint between wall and column existed.

Figure 8. Overturning of masonry walls in high stories due to out-of-plane seismic forces.

The Peruvian Masonry Code (SENCICO 2006) does not allow the construction type described. This code establishes that for a wall to be confined, the masonry wall has to be firstly built, and then the concrete of the columns can be poured. The connection between RC columns and masonry wall can be toothed, or vertical with added connecting wires in the horizontal joints anchored in the columns. The construction sequence used in the Pisco buildings does not provide vertical support to the masonry wall under out-of-plane seismic forces. Therefore, after the earthquake, in many cases it could be observed that the masonry walls fell by overturning, especially in the higher stories (Figure 8), in which the acceleration are larger and the gravity load is less. A suggestion for such existing walls is to tie the masonry to the columns by using welded wire mesh.

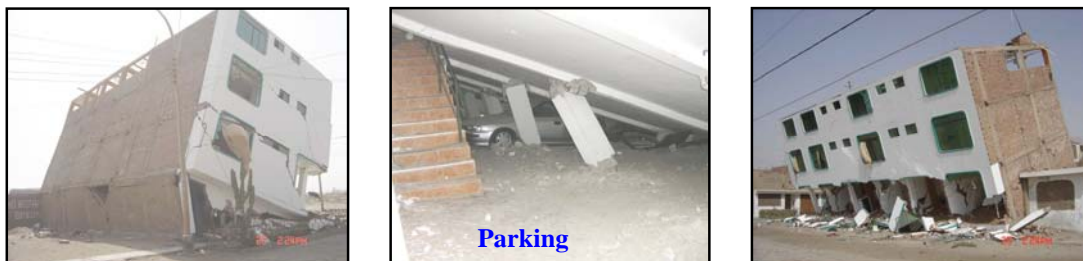
The soft story occurs due to a sudden change in rigidity between consecutive stories. In figure 9, along the shorter direction of the building, the first story walls did not continue for the use of parking area in the first floor, except the perimeter walls. The units of these walls are poor quality bricks, so the wall has low shear resistance. The walls at the building borders (corner) also produced an important torsional effect. Therefore, after the failure of the first floor walls in the short direction, the soft story problem developed and the whole building collapsed.

Figure 9. Soft story and torsion.

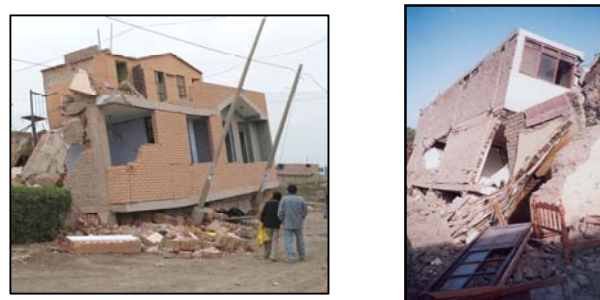
In the Peruvian Masonry Code (SENCICO 2006), buildings are required to have a minimum wall density in each direction, and, it must be verified that the provided wall resistance should be at least equal to the seismic shear force in the floor under analysis on a severe earthquake. The buildings shown in figure 10 were not only built with low quality bricks, but also had not enough wall density in the short direction as the Code requirement.

Figure 10. Low wall density

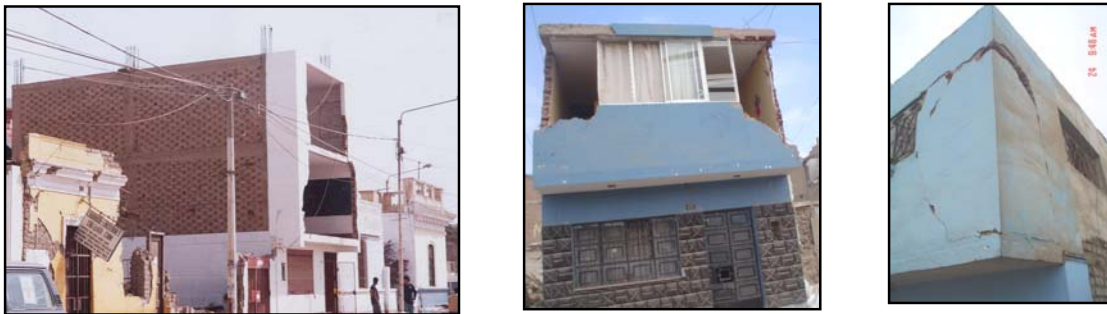
In some building façades, more area is added in the upper stories by cantilever slabs. Quite often, the walls in the room with part in cantilever are built using tubular bricks (called “pandereta” in Peru). Even though a toothed connection may exist with the orthogonal walls, it is not enough to resist the out-of-plane seismic forces, and fail by overturning (Figure 11) in a dangerous way, as they may fall over people getting out by the first floor. Such non bearing walls should be retrofitted, for example, using welded wire meshes.

Figure 11. Failure of cantilever facades by out-of-plane forces

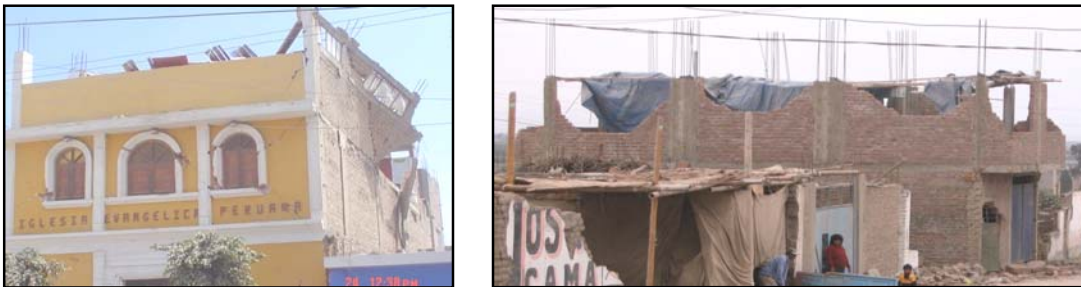
Several defects in the structural detailing could be observed in masonry buildings in the affected area. All of the following issues are mentioned in the Peruvian Masonry Code E.070 (SENCICO 2006) and were not complied: absence of diaphragms, missing collar beams, columns without continuity, beam-column joints without ties, and more. Some of the abovementioned situations are shown in figures 12 and 13.

Figure 12. Collapse of roofs and walls in buildings without rigid diaphragm

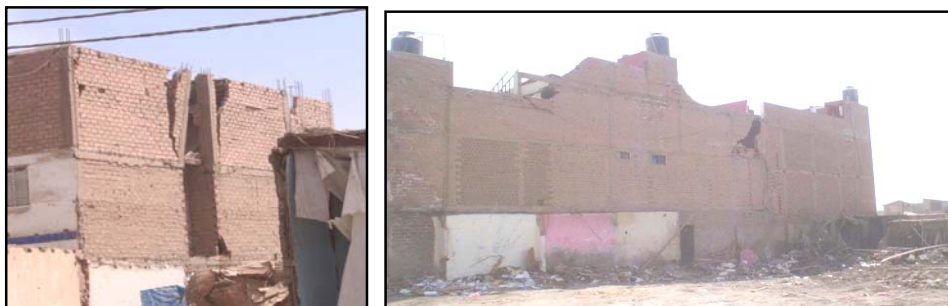
Figure 13. Walls without collar beam and column without continuity (left); bracing vertical columns too far apart each other (right); in both cases masonry failure is observed.

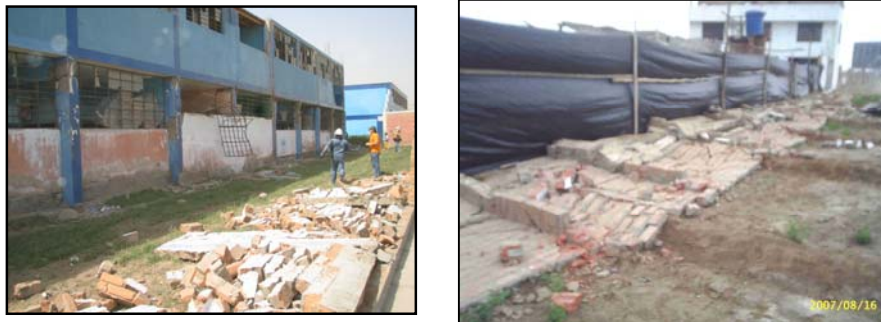
After the Pisco earthquake, in cities along the way between Lima and Ica, many perimeter walls and parapet walls collapsed by overturning, mostly due to lack of braces, or even when a rather small masonry wall was used as brace in the orthogonal direction. In several cases, the RC bracing columns collapsed together with the masonry wall due to lack of resistance, see Figures 14 and 15.

Figure 14. Perimeter walls collapsed by overturning. Masonry Piers are not enough.

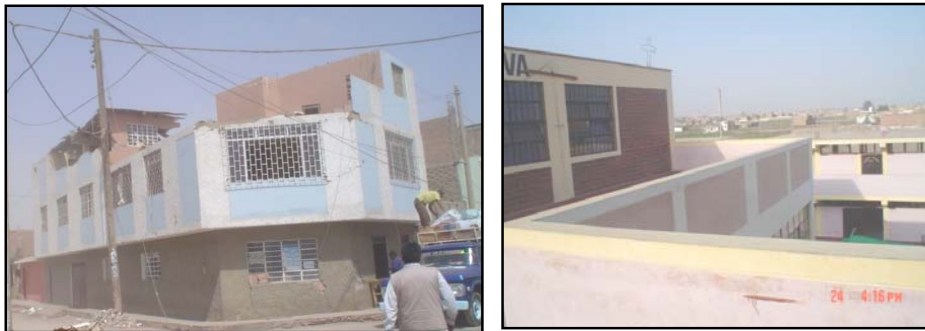
Figure 15. Parapet wall without bracing collapsed (left) and other adequately braced undamaged, both located on the third floor of their respective buildings, Pisco.
