13th World Conference on Earthquake Engineering
Vancouver, B.C., Canada
August 1-6, 2004
Paper No. 2447

EARTHQUAKE-RESISTANT PERFORMANCE OF PERUVIAN SCHOOL BUILDINGS

Alejandro MUÑOZ¹, Marcial BLONDET², Ursula QUINTANA³, Henry LEON³

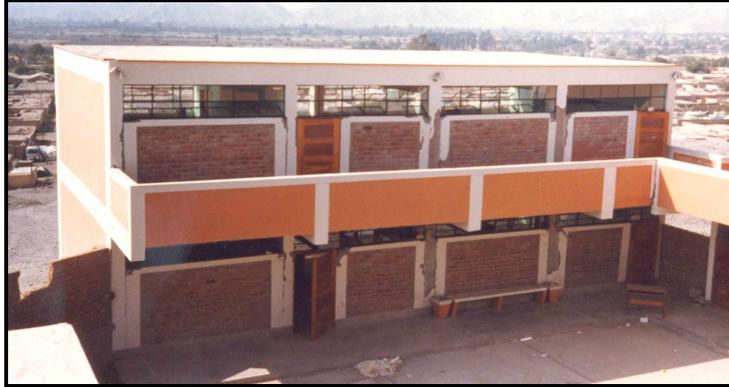
Peruvian school buildings have one to four stories. Their structural system is a combination of reinforced concrete frames and confined masonry walls. Floor systems are slabs with joists parallel to the facade. Figure 1 shows a typical school building of the coast of Peru. In the longitudinal direction the earthquake resistant system is composed exclusively of reinforced concrete frames parallel to the facade. In the transverse direction, seismic forces are resisted by masonry walls confined within R/C frames.

Figure 1. Typical Peruvian school building

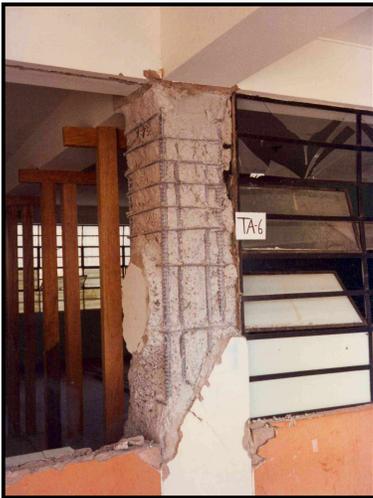
In all important earthquakes in Peru, traditional school buildings have suffered extensive damage because of the poor performance of the longitudinal frame system (Stratta *et al.* [3], Zegarra, Repetto [4], Muñoz *et al.* [5, 6]). The lack of stiffness of these frames is responsible for the well known problem of captive short column, which in some cases leads to important but repairable damage (Figure 2), and in other cases to damage so extensive and severe that repair is impossible.

Figure 2.
Short column failure, Nasca 1996 earthquake

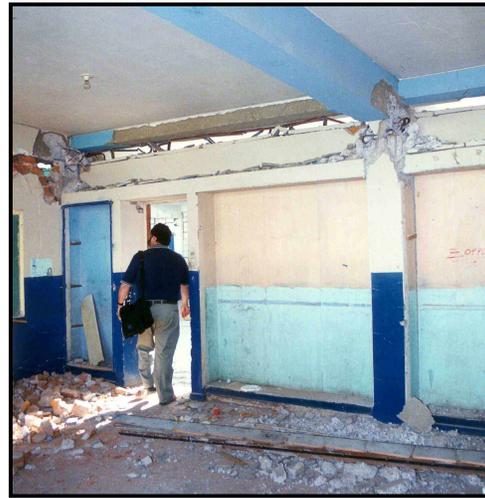
Figure 3.
Generalized short column failure. Atico 2001 earthquake

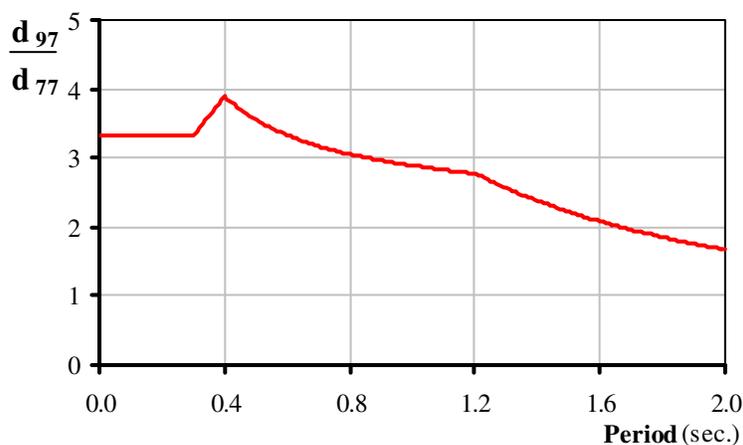
Figure 4 shows the ratio between expected lateral displacements for a given structure analyzed following the specifications of the 1997 and 1977 codes. For a specific short-period structure, the displacements obtained with the 1997 code are approximately 3.3 larger than those obtained with the 1977 code. Considering the reduction in permissible drift limits from 1% to 0.7%, the stiffness demands for short period buildings are 4.8 times larger.

Figure 4. Ratio of expected displacements according to 1997 and 1977 Peruvian seismic codes

Furthermore, the importance factor for school buildings was increased from 1.3 to 1.5. Since in the Peruvian code this factor is used directly in the calculation of lateral drift, the new stiffness requirements for school buildings are 5.5 times larger than those of the previous code.

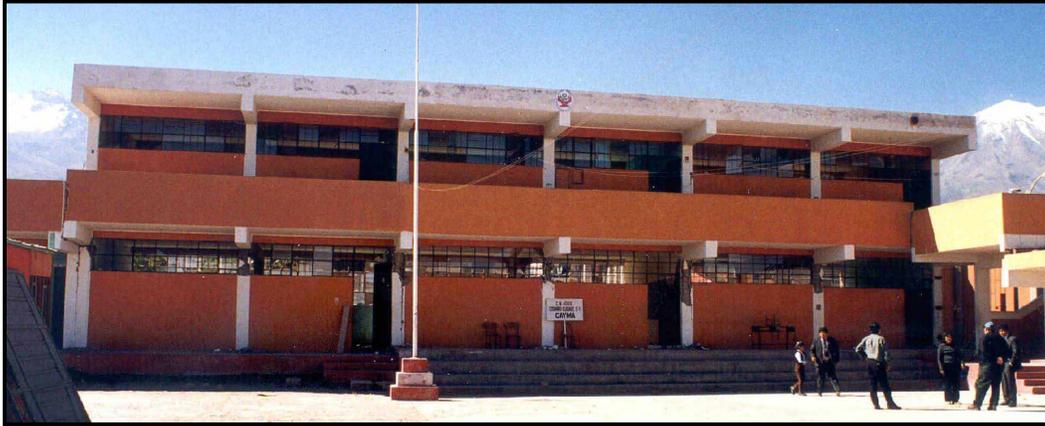
Figures 5 and 6 show, respectively, a traditional (pre-1997) and a modern school building after the 2001 Atico earthquake. The modern building was undamaged.

Figure 5. Pre-1997 school building with flexible facade beams and columns, damaged in the Atico 2001 earthquake

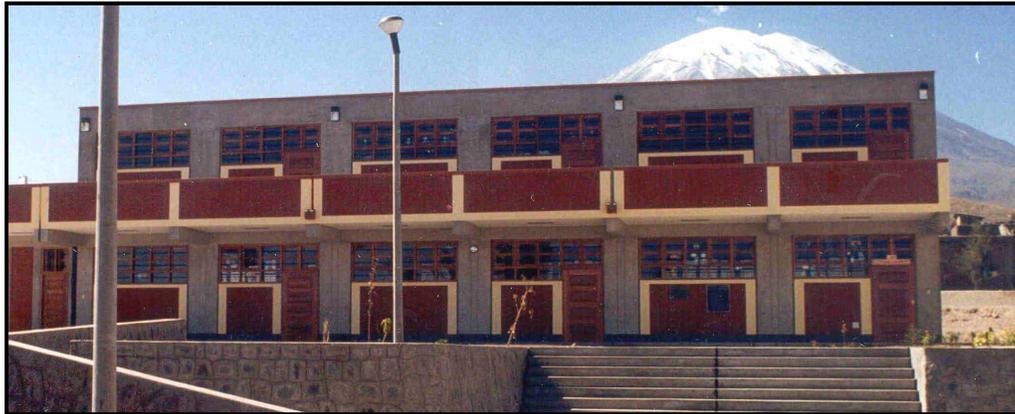
Figure 6. Modern school building, undamaged. Notice the larger beams and columns

The important change in stiffness requirements introduced in the 1997 seismic design code implied that, after 1997, school building structures had to be significantly more rigid in the longitudinal direction. Facade beams, which were traditionally 0.25m wide and 0.30 to 0.45 m high, were replaced by beams measuring 0.25 x 0.55 m. Rectangular section columns 0.3 m wide were replaced by T-section columns with flanges measuring 0.90 to 1.20 m. The structural system in the transverse direction, with confined masonry walls, remained the same, since it satisfied the stiffness requirements of the new code.

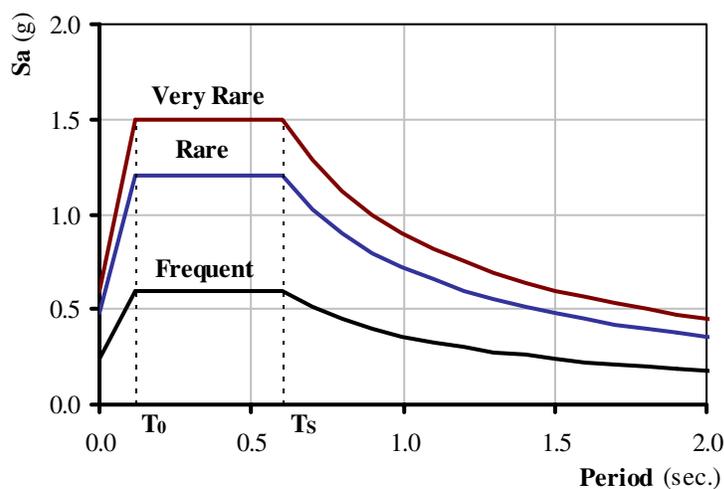
Acceleration response spectra for intermediate soil conditions corresponding to the 3 levels of seismic hazard were calculated using a soil factor of 1.2. They are shown in Figure 8 below.

Figure 8. Response spectra for three levels of seismic hazard

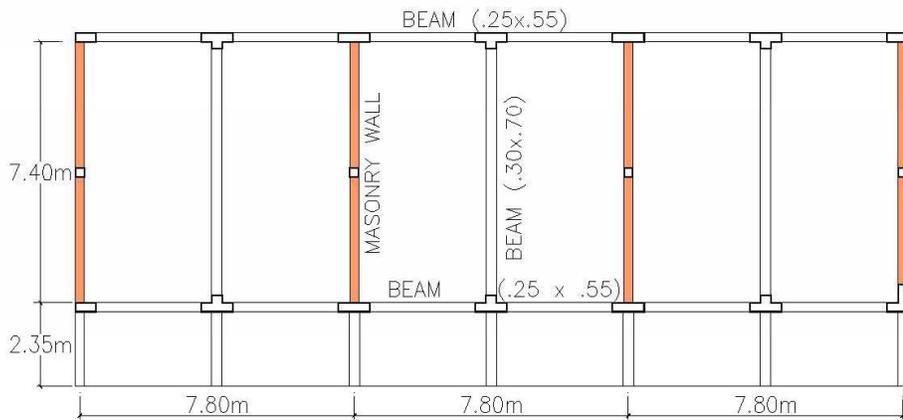
Figure 9 shows the structural system of the modern school buildings selected for this study. In the transverse direction the earthquake resisting system is composed of confined masonry walls, also used to separate the classrooms. In the longitudinal direction, two reinforced concrete frames are provided, with robust beams and columns.

Figure 9. Structural floor plan

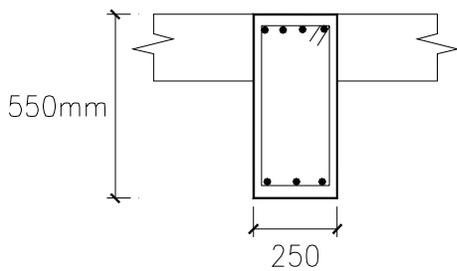
Figures 10 and 11 show sections and reinforcement of beam and columns of the two-story modern school building selected.

Long. Reinforcement: 7#5
Closed hoops: #3,
1@50, 10@100, r@250mm

Figure 10. Longitudinal beam section of a typical two-story school building

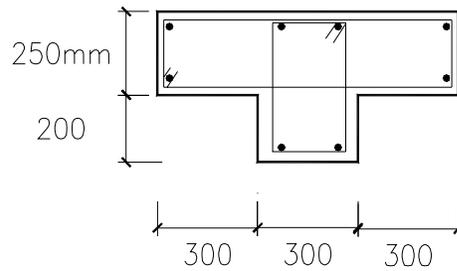
Long. Reinforcement: 8#6
Closed hoops: 2#3,
1@50, 9@100, r@200mm

Figure 11. Column section of a typical two-story school building

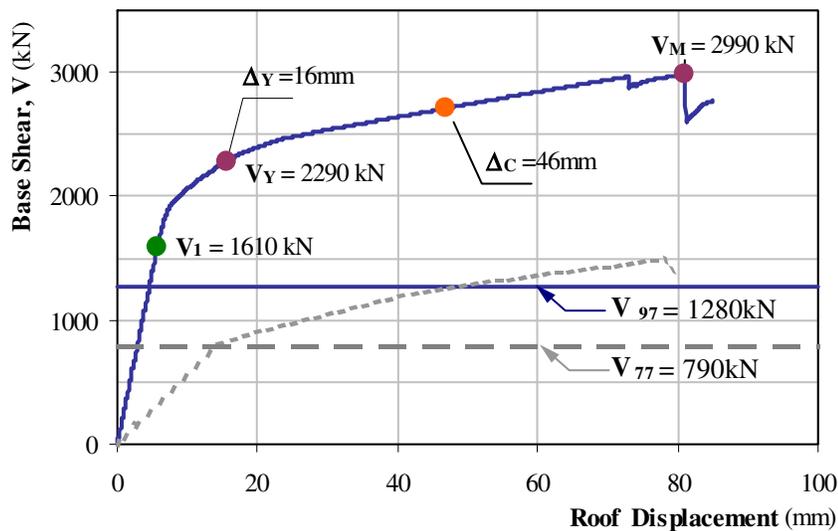
Figure 12 shows the capacity curves for the selected two-story school buildings. A solid line is used for the modern building, a dashed line for the traditional building. Horizontal lines indicate the base shear strengths required by the 1997 and 1977 codes (V_{97} and V_{77} , respectively).

Figure 12. Force displacement curves for modern and traditional 2-story Peruvian school buildings

The maximum shear strength of the modern building, V_M , equal to 2990 kN, is 1.85 times larger than the lateral force corresponding to the formation of the first plastic hinge, V_I , and 1.3 times larger than the effective yield strength, V_Y . Notice that V_I and V_Y are, respectively, 1.26 and 1.80 times larger than the 1997 design base shear V_{97} of 1280 kN.

The modern building is able to develop a global displacement ductility approximately equal to 5, corresponding to a yield displacement of 16mm and an ultimate displacement of 81 mm. The maximum drift permissible by the 1997 code (0.7%) is reached, however, with a displacement of 46 mm, which roughly corresponds to the midpoint of the available inelastic range. The traditional building showed similar values for the maximum lateral displacement and global ductility.

The lateral strength of the traditional building is considerably smaller than that of the modern building (less than 50% for the effective yield force). This difference is due to several factors, such as the increase of importance factor in the new code (from 1.3 to 1.5), the increase in the design spectrum platform width (from 0.3 to 0.4 s), the larger overstrength of rigid structures, and basically because rigid modern structures reach significantly higher spectral ordinates, and thus reach a higher strength than traditional flexible structures.

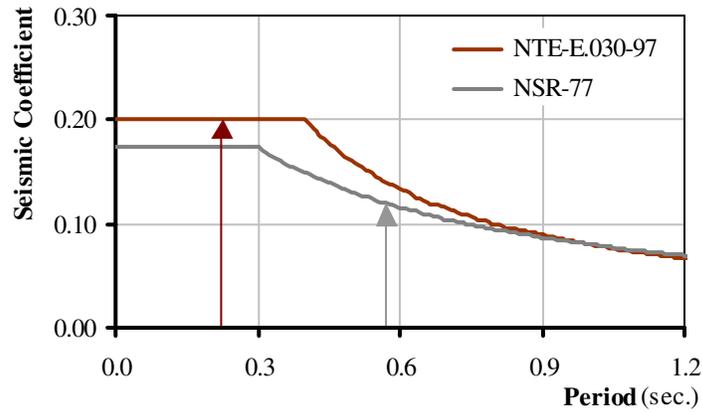
Figure 13. Seismic coefficient for two-story school buildings according to 1997 and 1977 codes. Arrows correspond to the selected buildings

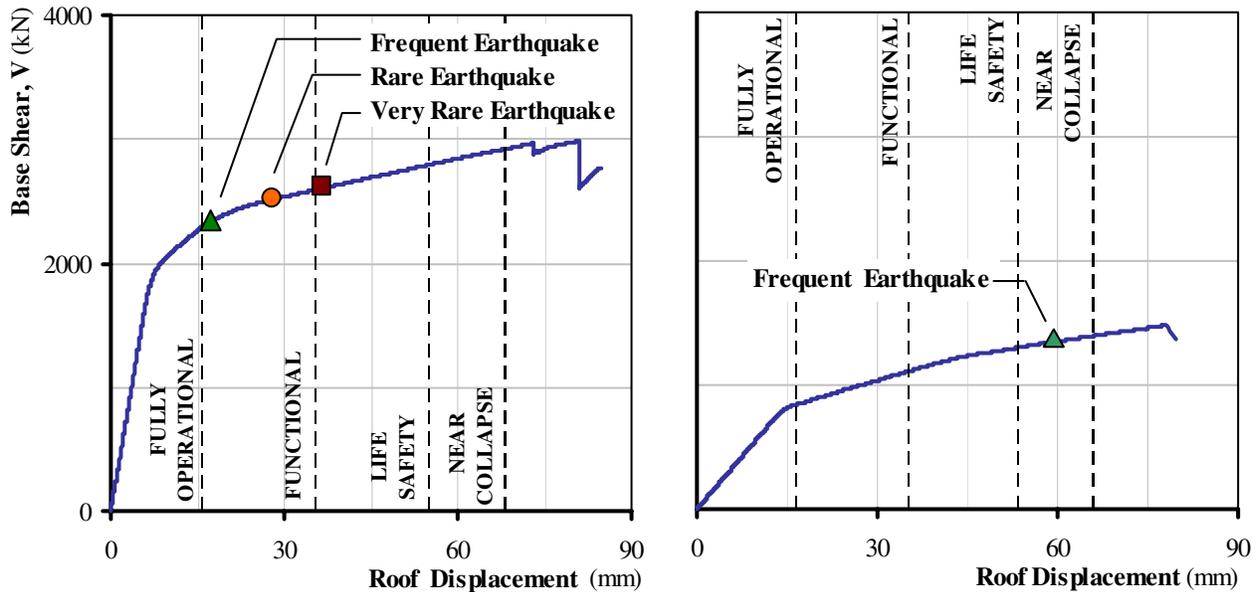
The capacity curves of both buildings were subdivided according to suggestions of SEAOC [9]. The demand points corresponding to the three levels of seismic hazard, estimated according to the procedure suggested in ATC40 [11], were located in the corresponding curves, as shown in Figure 14.

Figure 14. Demand points for modern (left) and traditional (right) two-story school buildings

Similar results were obtained for the 3-story school buildings. Therefore, the analytical study indicates that in a frequent earthquake, the modern buildings would be slightly over the desired full operational level. In stronger earthquakes, the buildings would attain the desired performance: they would be functional after a 500 year event and would provide life safety after a very rare 1000 year event. The traditional buildings, on the other hand, would have unacceptable performance: they would be subjected to high inelastic displacement demands and be near collapse even during frequent earthquakes, and would possibly collapse in stronger events.

These results are conservative, but in general agreement with the observed performance of traditional and modern school buildings during the Atico earthquake, where the soil conditions and peak acceleration in many cities were consistent with the assumptions made for this study of frequent earthquake and intermediate soil conditions (ASCE [13]). Analysis results predicted slight damage in modern buildings after a frequent earthquake, but no damage was reported in the modern schools located in the area. Extensive damage, close to collapse, was predicted for traditional buildings. Although many traditional school buildings suffered damage due to the short column effect, even with a 25 mm separation between the frame and the non-structural walls, only a few were near collapse. The conservatism of the analysis results might be due to material overstrength and limitations of the modeling technique.
