Seismic Reinforcement of Confined Masonry Walls made with Hollow Bricks using Wire Meshes

A. San Bartolomé, D. Quiun, K. Barr & C. Pineda

Pontifical Catholic University of Peru

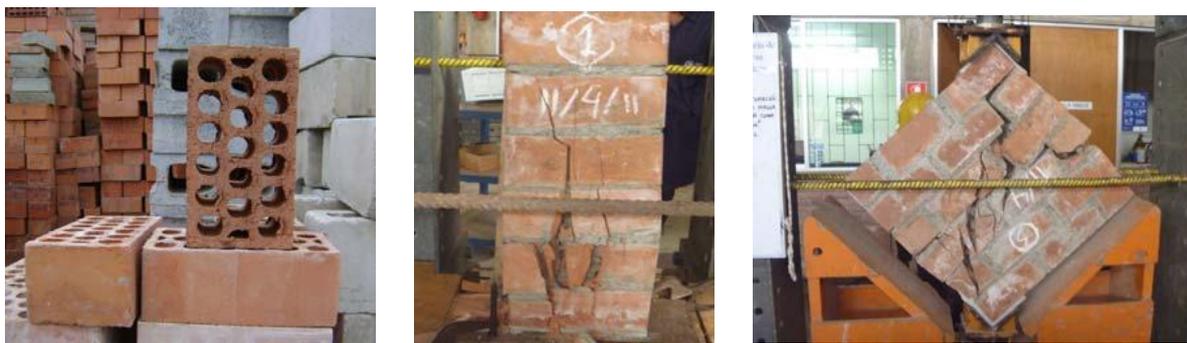
Figure 2. Hollow brick (left) and typical failure of prisms (centre) and small walls (right).

Three masonry prisms (125x230x600 mm) were tested under axial compression, giving an axial resistance of masonry $f'_m =7.8$ MPa. The failure was brittle with some crushed bricks (Fig. 2). Also, small walls (125x600x600 mm) were tested under diagonal compression, providing a shear resistance $v'_m = 0.72$ MPa. The failure was brittle, mostly along the joints and cutting or crushing some of the hollow bricks (Fig. 2).

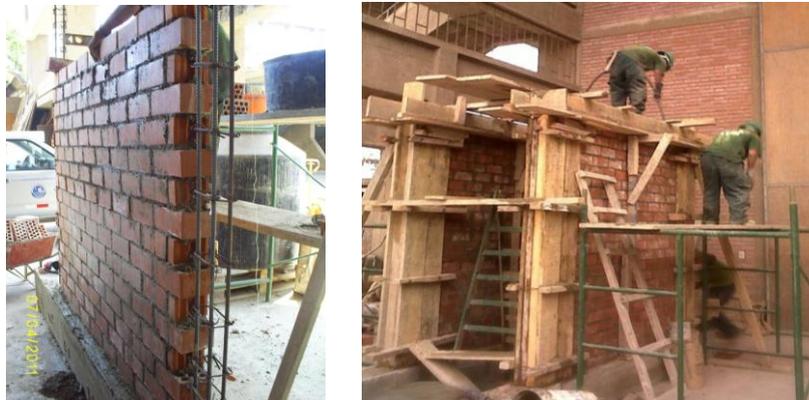
Figure 4. Construction of masonry walls W1 and W2.

The construction of both walls was done using similar materials, the same workmanship and similar reinforcing bars in the confinement elements. Other characteristics were that the brick layout was set using the smaller unit thickness as wall thickness, and toothed connections were used between the wall and the columns, as it is usual in Peru. In order to reduce their natural initial suction, the clay bricks were watered with a hose for 30 minutes about 10 hours prior to use. This procedure is recommended by the Peruvian Masonry Code to achieve an optimal suction in clay bricks at the time of placement. The confinement concrete cover was 30 mm. The concrete was prepared in a mixing machine, had a 100 mm slump and was compacted with a vibrator. The masonry wall was built in two days, followed by the pouring of the concrete of the columns. Finally, the collar beam was poured. Figure 4 displays part of the masonry wall construction.

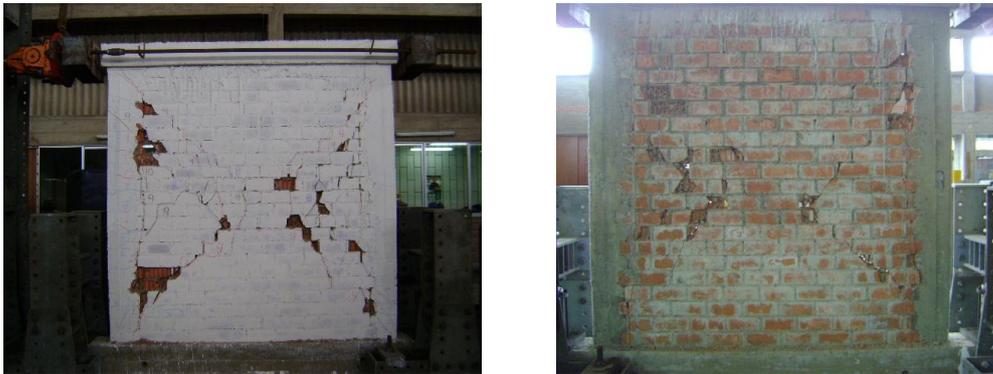
Figure 7. Both sides of Wall W1 at the end of the Test

As it was previously predicted, tension flexural cracks appeared at the column bases in wall W1. Also as it was predicted earlier, wall W1 had a shear failure with diagonal cracks and crushing of the hollow bricks (Figure 7). This brittle behaviour is common for this kind of walls (San Bartolome et. al., 2011) which is why the Peruvian Masonry Code forbids the use of hollow bricks in structural masonry walls.

When the harmonic load was applied to wall W1, the bricks crushed a lot, even though the lateral

displacement amplitude was 15 mm, less than 20 mm, which was the last step amplitude of the cyclic load test. In the case of wall W2 the crushed column base ended completely broken. Figure 7 shows Wall W1 and Figure 8 shows wall W2 at the end of the harmonic tests.

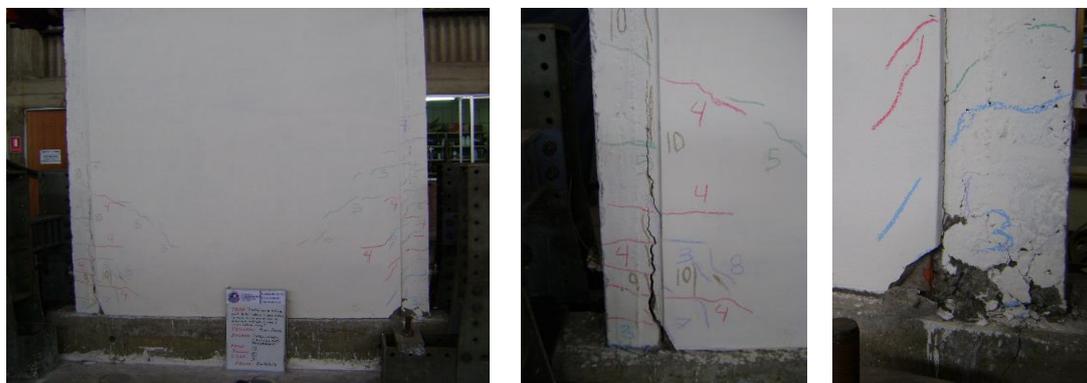
Figure 8. Wall W2 with detail of the column failures (bond and crushing)

Wall W2 had a flexural failure, with quite thin shear cracks in the masonry controlled by the wire mesh reinforcement. The final failure was a vertical crack in one of the columns, losing the bond between steel bars and concrete, while the other column's base was crushed (Figure 8).
