SEISMIC PROTECTION OF BUILDINGS IN PERU USING ENERGY DISSIPATION AND BASE ISOLATION

M. Tinman⁽¹⁾, D. Quiun⁽²⁾, A. Muñoz⁽³⁾, L. Speicher⁽⁴⁾

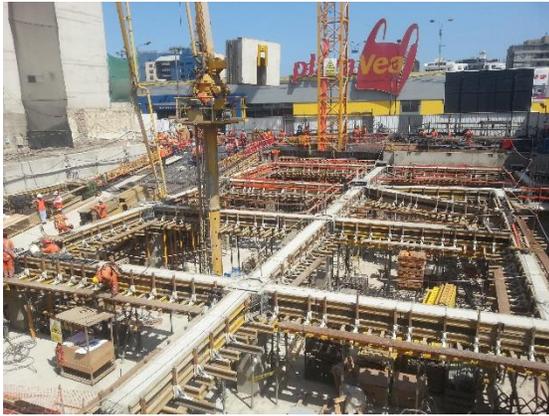
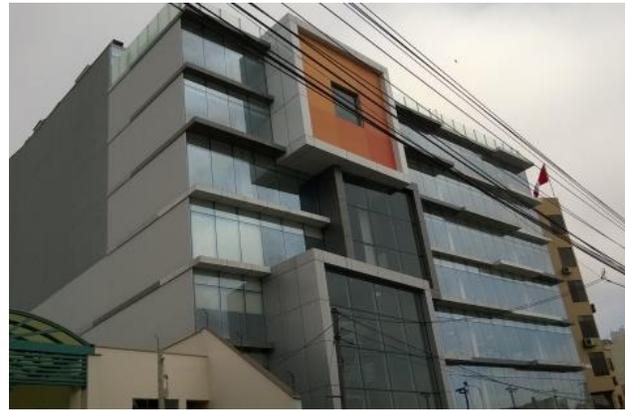
Fig. 1 “GyM” office building– Lima, Peru

The first office building with isolators built in Peru, was the building of private company GyM headquarters office (Fig. 1) designed by the structural firm "Prisma" in 2013. Regarding such building, a cost comparison was done of the isolated building with respect to a conventional design (with RC frames and walls). The result of the study conducted by Prisma and GyM, gave that the isolation system was only 3% more expensive compared to the conventional system.

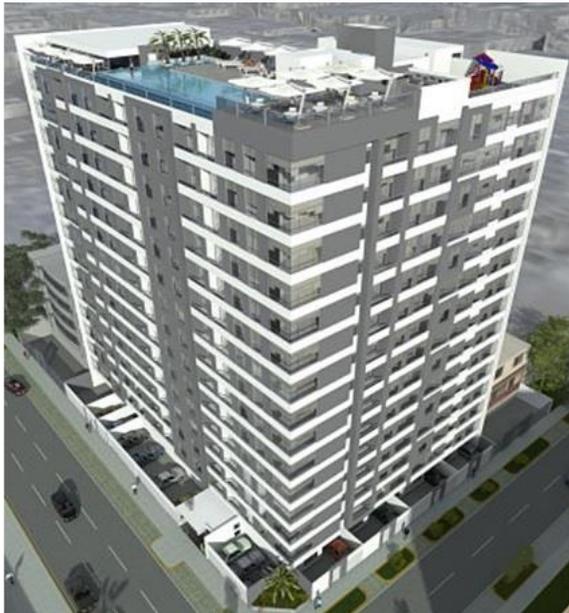
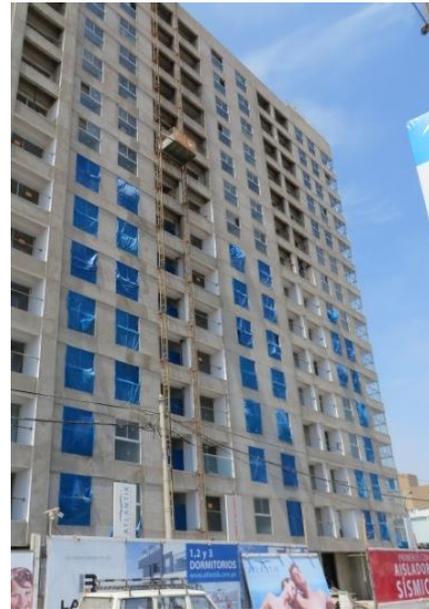
Fig. 2 “Atlantik Ocean Tower” building in Lima, Peru

In 2014, the real estate “Labok” built the first apartment building with seismic isolators called “Atlantik Ocean Tower” in which the structural design was by Prisma. This 15-story plus 4 basements building, has 40 elastomeric isolators and friction sliders (Fig.2). Subsequently, Prisma developed in 2015 the first building for economic housing apartments, using a system of seismic protection. This building called “Paseo Colonial” has started construction in May 2016; it has 15 floors plus 2 basements and 72 elastomeric isolators (Fig. 3).

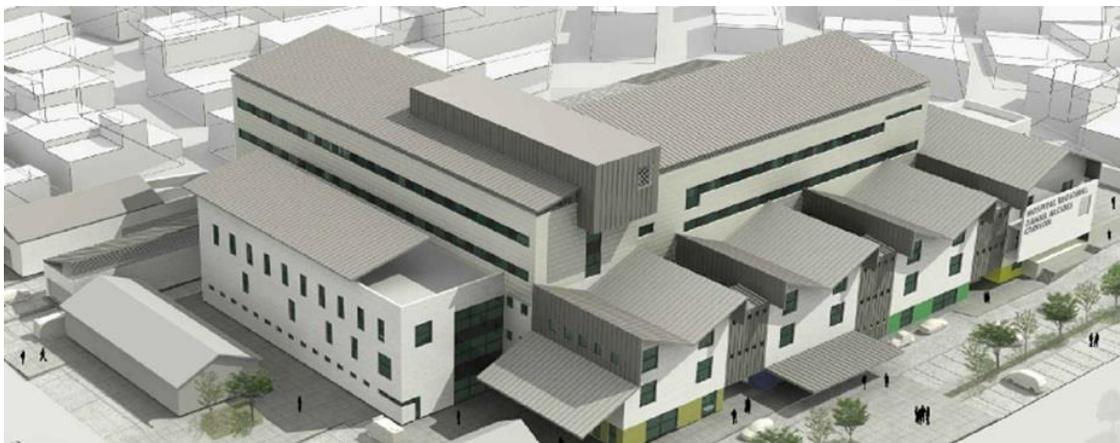
Fig. 4 “Daniel Alcides Carrión Hospital” in Cerro de Pasco, Peru

Since 2014, an addendum to the Peruvian seismic code, has been enforcing that major hospitals must have seismic base isolation, if they are in seismic zones 3 and 2 of the 2003 Peruvian seismic code [6]. The new Seismic Code that was recently published in January 2016 keeps this requirement. Therefore, currently there are more than 10 hospitals in design or construction with an elastomeric system of isolation, as the one shown in Fig.4. Also, some private clinics took the initiative to incorporate isolation systems in new buildings. This is the case of the Medical Specialties Clinic in San Borja, Lima, or The Hamilton Naki Clinic in Huancayo. However, since the publication of the Code in January 2016, the new buildings in private clinics are required to have base isolation, if they are located in the new seismic zones 4 and 3, and they belong to the second and third tier in the classification of health establishments from the health ministry of Peru.

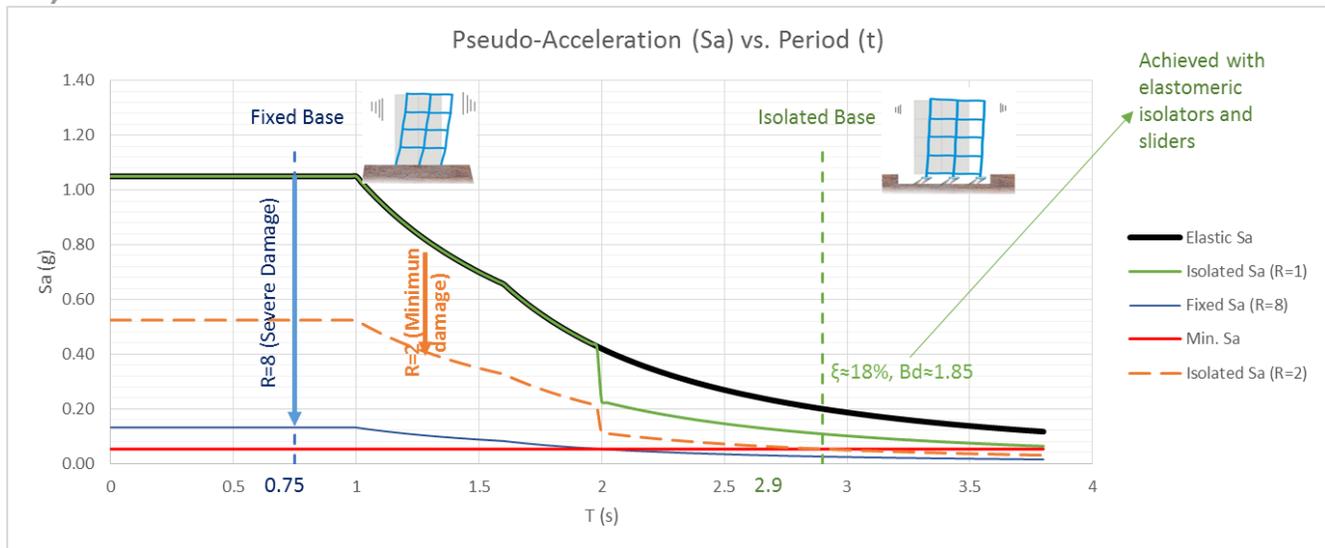
Fig. 5 Reduced demand using seismic isolation for Rioja Hospital in Peru

In Fig. 5, the global result of the design achieved for the Chilean company Sirve in alliance with the Peruvian company Prisma for the Rioja Hospital of Peru is shown. The original vibration period of 0.75 s was moved to 2.9 s (almost 3.9 times). The pseudo acceleration for design, using the damping reached, was on the lower limit of the pseudo acceleration specified by the Peruvian seismic code.

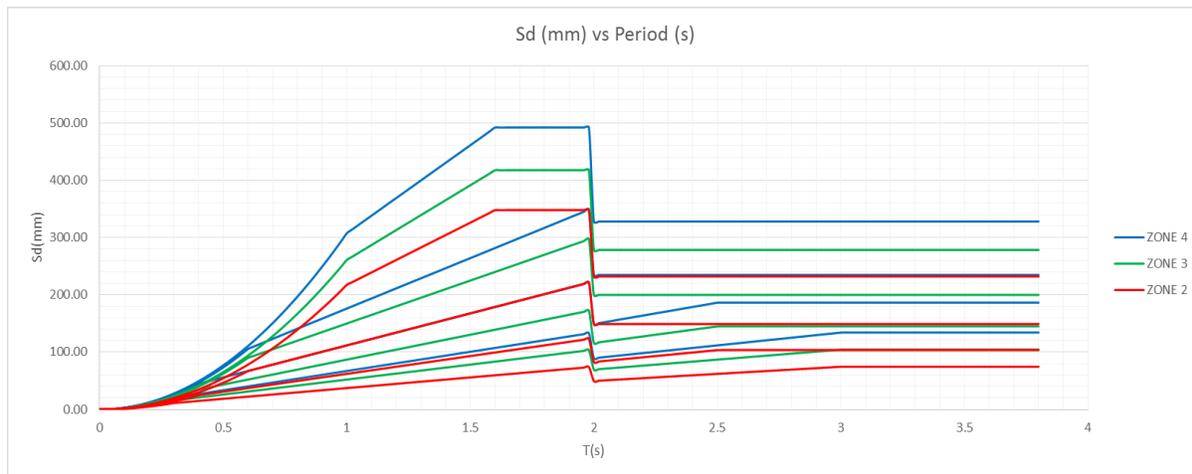
Fig. 6 Displacement spectra according to the Peruvian seismic code (2016)

The displacement spectra for isolated buildings, obtained using the 2016 Peruvian Seismic Code, on the three seismic zones of higher hazard (zones 4, 3 and 2), and the four types of soils defined in the Code, are shown in Fig. 6. A correctly designed building in seismic zone 4 (the most hazardous), without torsional effects and having an effective damping of 20%, should have a seismic joint less than 400 mm between the isolated and non-isolated parts. If the same building is located in seismic zone 3, the seismic joint could be less than 300 mm, and for seismic zone 2, it could be less than 250 mm.

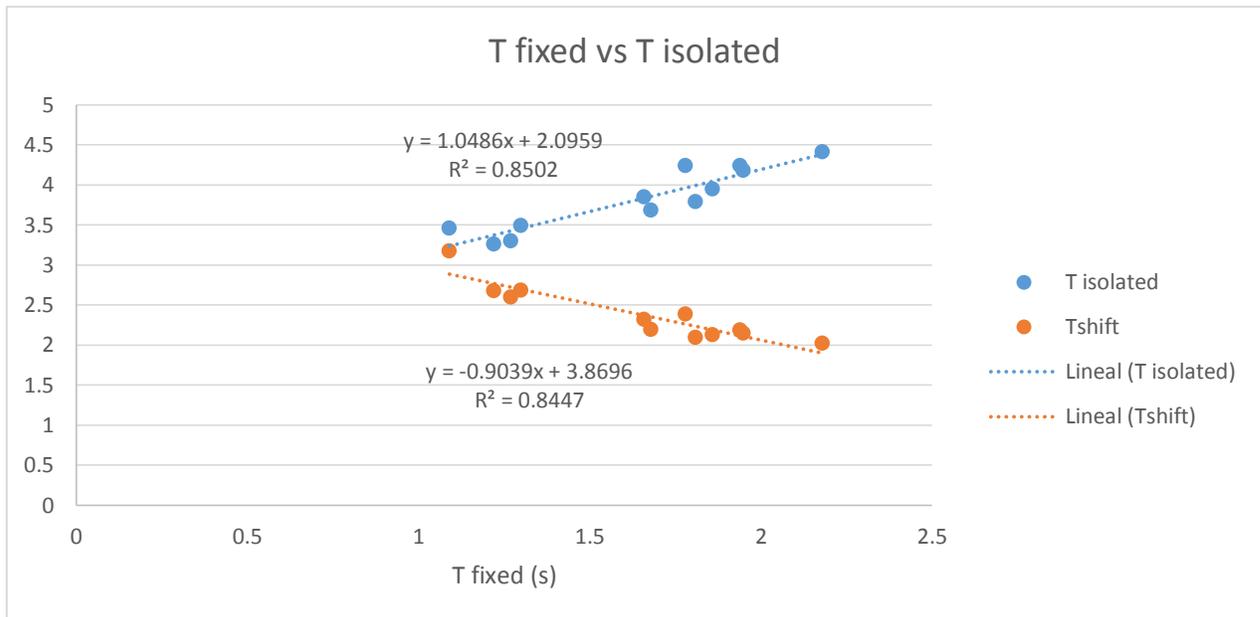
Fig. 7 Relationship between fixed and isolated period

Figure 7 shows the relationship between the fixed base period and the period with seismic isolation. Also, it can be observed the difference between the isolated period and the fixed period for the buildings in Table 2.

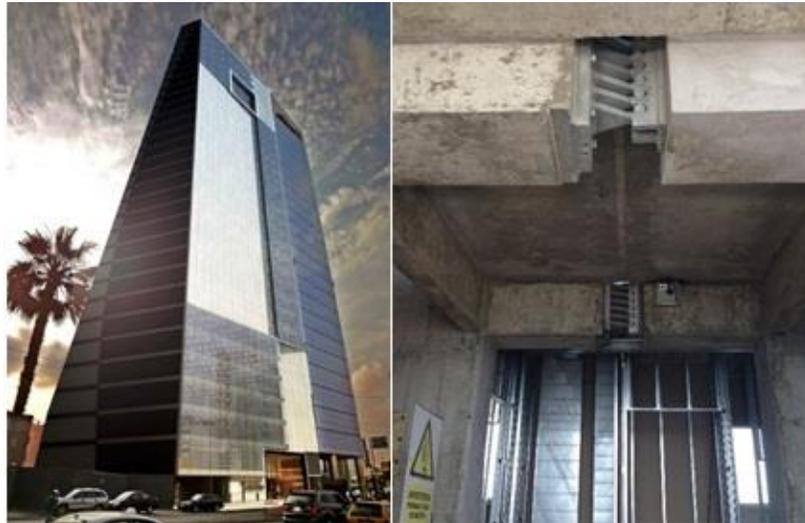
Fig. 7 “Barlovento Tower” building in Lima, Peru

Some of the most representative new buildings with energy dissipation systems in Perú are as follows. The “Barlovento Tower” is a new office building with 31 stories and 9 basements, designed with 156 hysteretic dampers TADAS, located between coupling beams that connect the structural walls of the elevators (Fig. 7). The construction of this building ended in 2015. Till now, this is the tallest building in Peru having an energy dissipation system. Also, the “Orquídeas Tower” is another office building, with 27 stories and 10 basements that finished its construction by the end of 2015. The design included 94 hysteretic dampers TADAS, in locations and distribution similar to the Barlovento tower (Fig. 8).

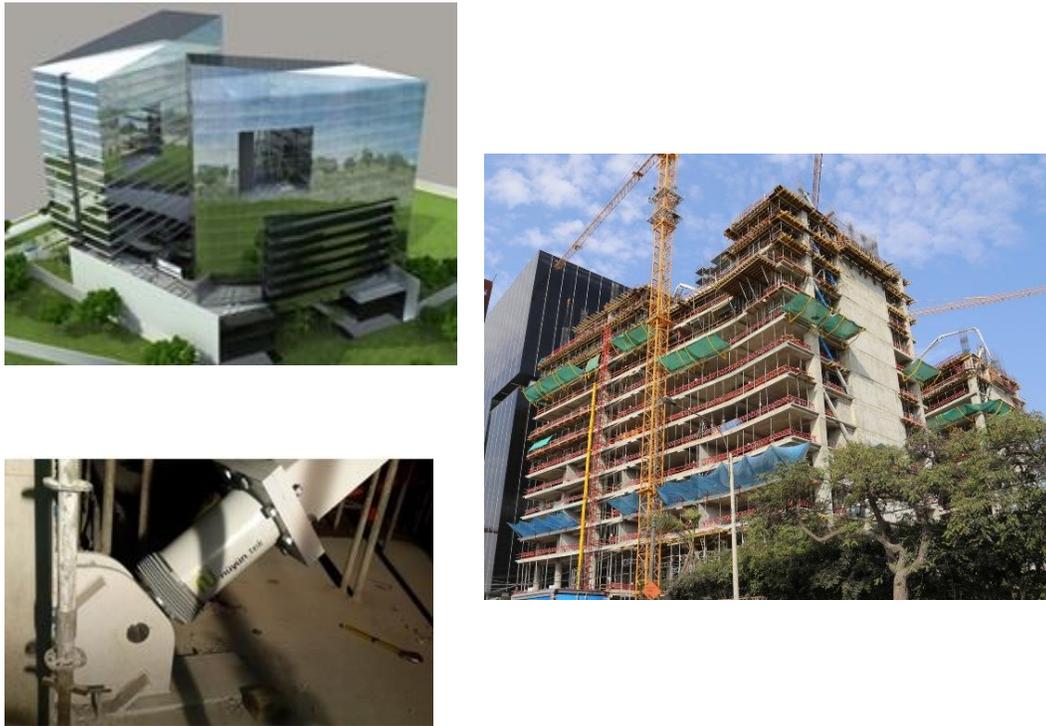
Fig. 9 “Panorama business center” tower buildings in Lima, Peru

Regarding seismic energy dissipation devices in Peru, the “Panorama Business Center” is an office building that has a singular role (Fig. 9). The project consists in two building towers of 20 stories each, and 8 common basement levels. This was the first project having viscous dampers, featuring 39 of such devices in each tower. The construction started in 2012, and finished in 2015. There were strict tolerances in the fabrication and construction of the steel structural elements holding the energy dissipation devices, which enforced the local factories to improve their control process in order to handle the small installation tolerances.
