EXPERIMENTAL STUDY TO AVOID THE SLIDING FAILURE IN REINFORCED MASONRY WALLS UNDER LATERAL LOADS

A. San Bartolomé¹, W. Silva², E. Melendez³, G. Castro⁴, and D. Quiun⁵

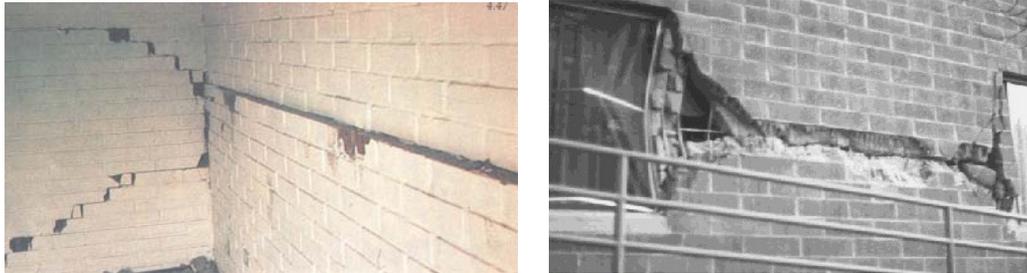
Figure 1: Sliding failure in masonry walls, Chile (1985) and Northridge (1994)

In reinforced masonry buildings subjected to strong earthquakes, a sliding failure (or shear friction failure) may occur, due to several reasons. Such failure is very dangerous, because the vertical bars can be cut, the reduction of the cross section is significant, and the wall can be broken into two parts, generating eccentricity of the vertical loads (Figure 1). An experimental research was conducted at the Structures Laboratory of the Pontifical Catholic University of Peru (PUCP) in order to find how to prevent the sliding failure of reinforced masonry walls under

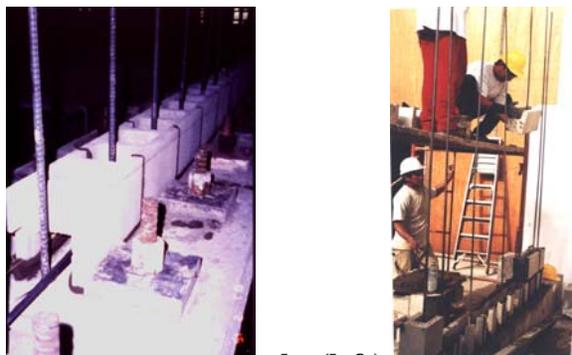
Figure 2: The use of H-shape blocks (left) avoid the overlap of bars and reduces the placement time when using conventional blocks (right).

The second factor may be the overlap of vertical reinforcement. In the traditional construction process of reinforced masonry walls, dowel bars are left anchored to the foundation; after the wall is finished, the vertical bars are installed, overlapping with the dowels. The surface in which the dowels end, becomes a weak plane where the sliding failure may occur. To avoid the problem with the overlaps, in some countries a special H-shape block is used (Figure 2), that lets the vertical bars be continuous. If conventional blocks are used with continuous vertical bars, the placement of the masonry units is slow due to the time required to insert and lower the blocks through the bars.

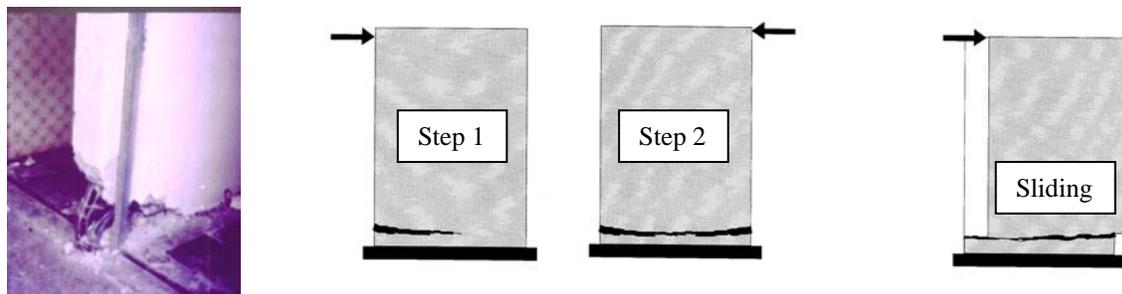
Figure 3: Flexure failure becomes a sliding failure

The uniform distribution of vertical reinforcement is the fifth factor. Traditionally, the vertical reinforcement is uniformly distributed along the wall. If the reinforcement at the wall ends consists of the same bars along the rest of the wall, it may not be enough to control the wall base rotation when it is subjected to high seismic forces. This fact provokes the crushing of the wall ends, and favours the horizontal flexural cracks to extend towards the middle of the wall. As the seismic load is cyclic, the horizontal cracks end up in a sliding failure (Figure 3).

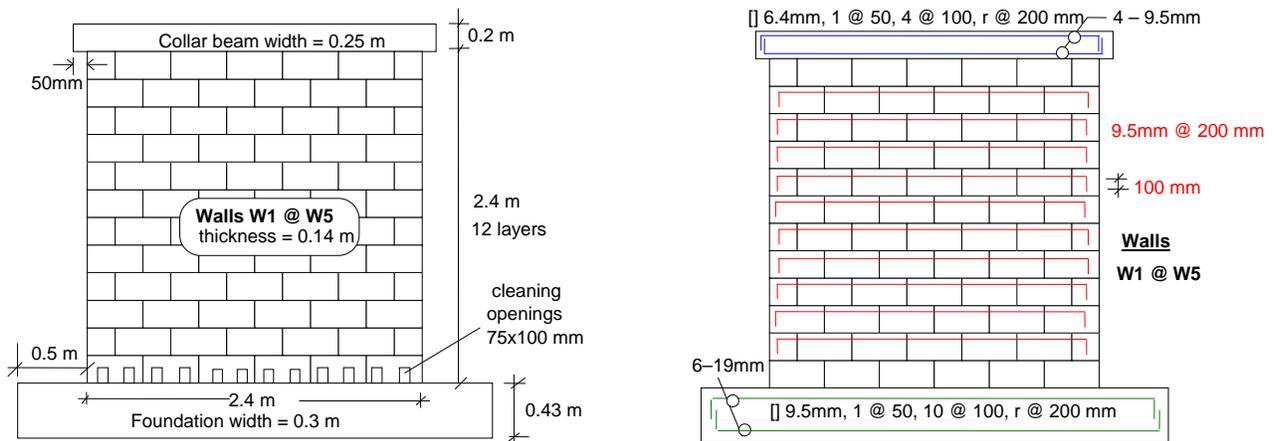
Figure 4: Common characteristics of the five walls

A total of five full-scale walls were constructed. All had several common characteristics, as follows: dimensions were 2.4x2.4x0.14 m; wall thickness was 0.14m; the concrete blocks featured slots to allow the horizontal reinforcing bars; the mortar mix was 1:1/2: 4 cement: lime : coarse sand; the cement for the mortar was Portland type I and the sand was sieved between meshes ASTM #4 and #200; all joints were 10 mm thick; the reinforcing bars steel had yield point at 420 MPa (60 ksi); the grout was prepared in a mixer machine; the slump was controlled to be 250 mm (10"); the walls were constructed in two days by the same qualified labour men; all blocks of the first layer had cleaning openings of 75x100 mm (3"x4") in each cell; the grout was poured in two layers, each one was compacted with a 16 mm (5/8") bar with an interval of 30 minutes between layers; the horizontal reinforcement was 1-9.5mm (3/8") bar each 0.20 m, a ratio of 0.0025, while the vertical reinforcement total ratio was 0.0024. Finally, both foundation beam and collar beam had the same cross section, concrete quality and reinforcement.

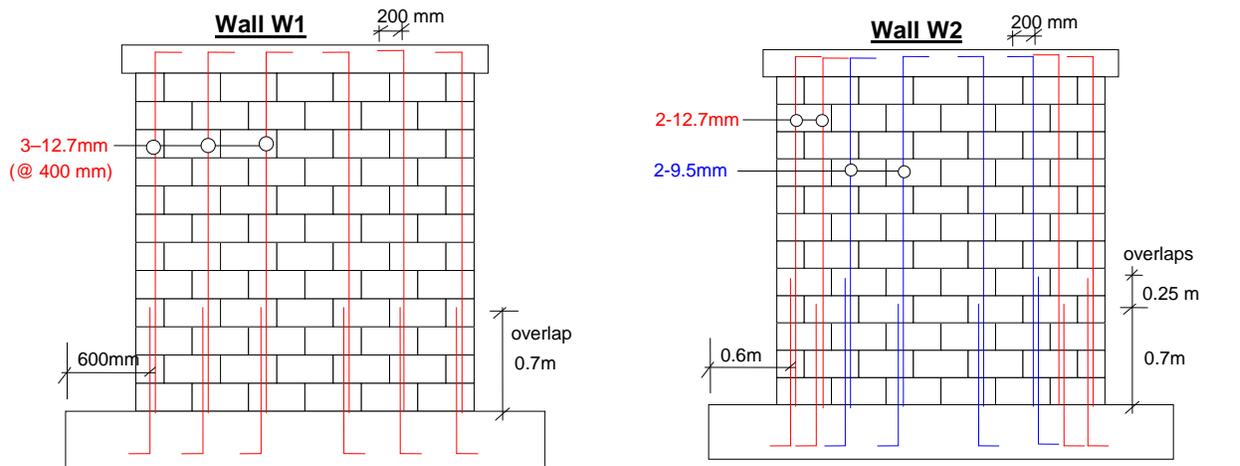
Figure 5: Vertical reinforcement of walls W1 and W2

For wall W1 the traditional construction sequence was followed. For the rest of the walls, table 1 show the variations used in their construction. Figures 4 to 9 show the wall characteristics and some aspects of the construction. The inverted blocks of the first layer used in walls W3 and W4 should be especially noted.

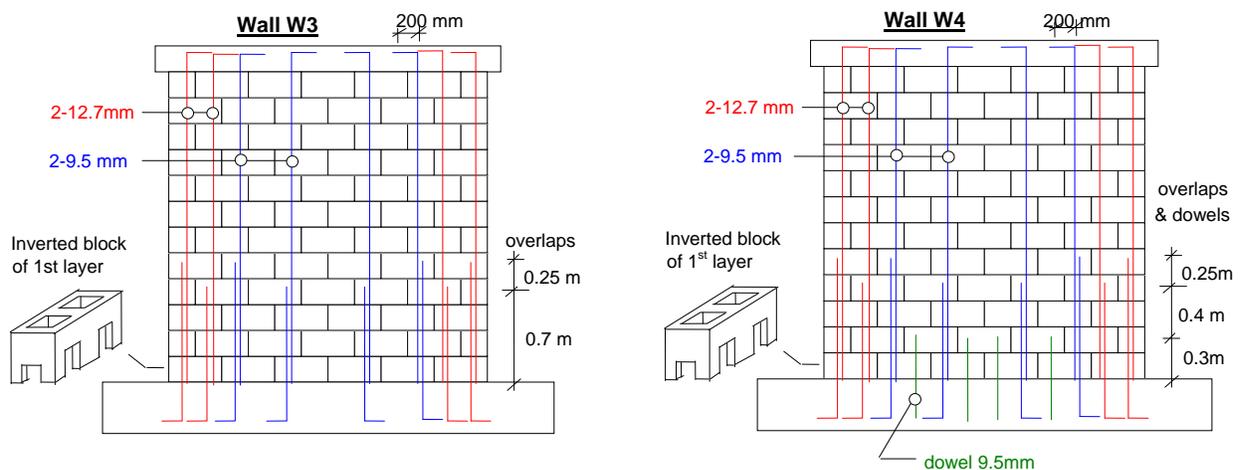
Figure 6: Characteristics of walls W3 and W4

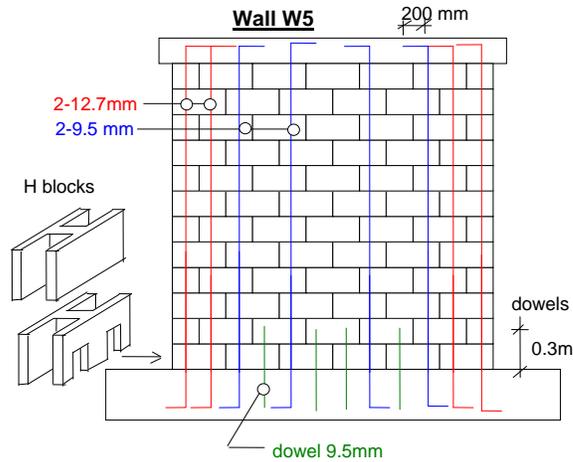
Figure 7: Characteristics of wall W5

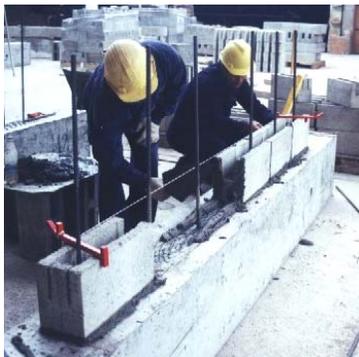
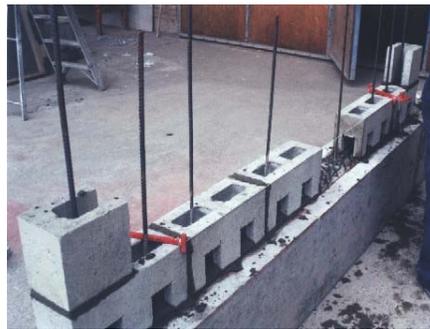
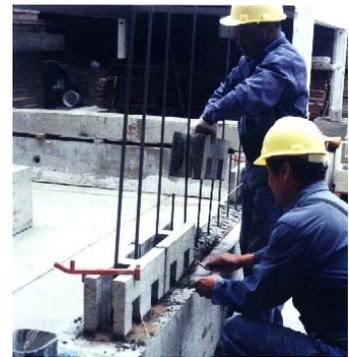
Figure 8: Construction of walls W1 (left), W3 (centre) and W5 (right)

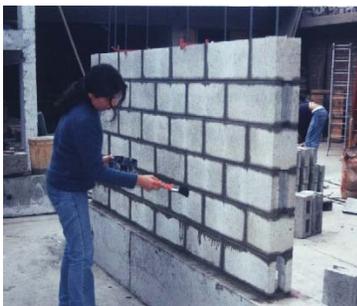
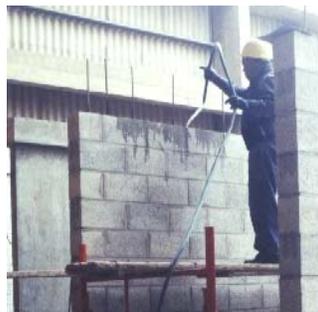
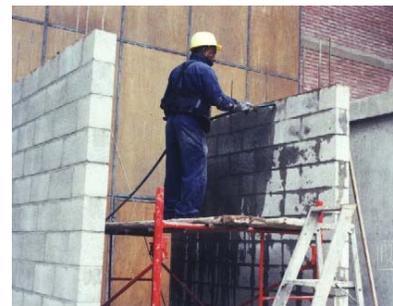
Figure 9: Treatment by watering of walls W4 and W5

The treatment by watering done to walls W4 and W5, as well as the use of pozzolanic cement IP, improved slightly the adhesion between blocks and grout. The drying shrinkage of the grout was lowered in both cases. However, this improvement did not increase the resistance in wall W3 because it failed by sliding.

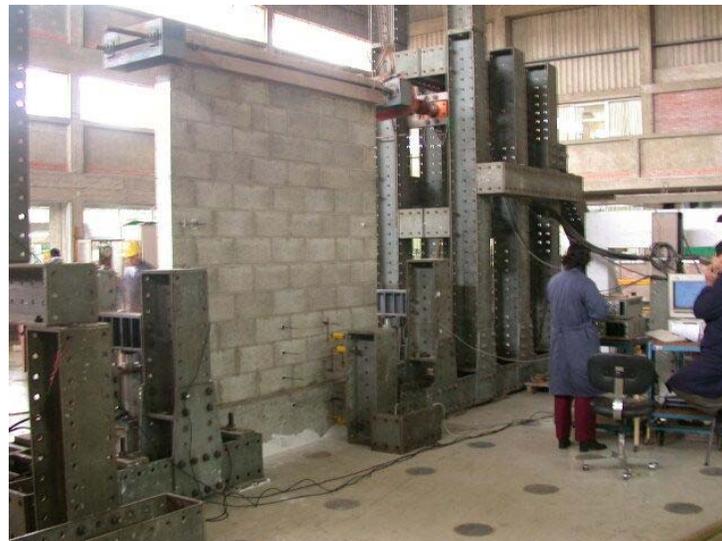
Figure 10: Test setup for cyclic lateral load

The five walls were subjected to cyclic lateral load tests with the setup shown in Figure 10. The horizontal displacement of the collar beam (named D1) was controlled with ten steps of increasing amplitude (Table 3). Hysteretic curves for walls W1 and W4, and envelopes of the first cycle of the five walls are shown in Figure 11.

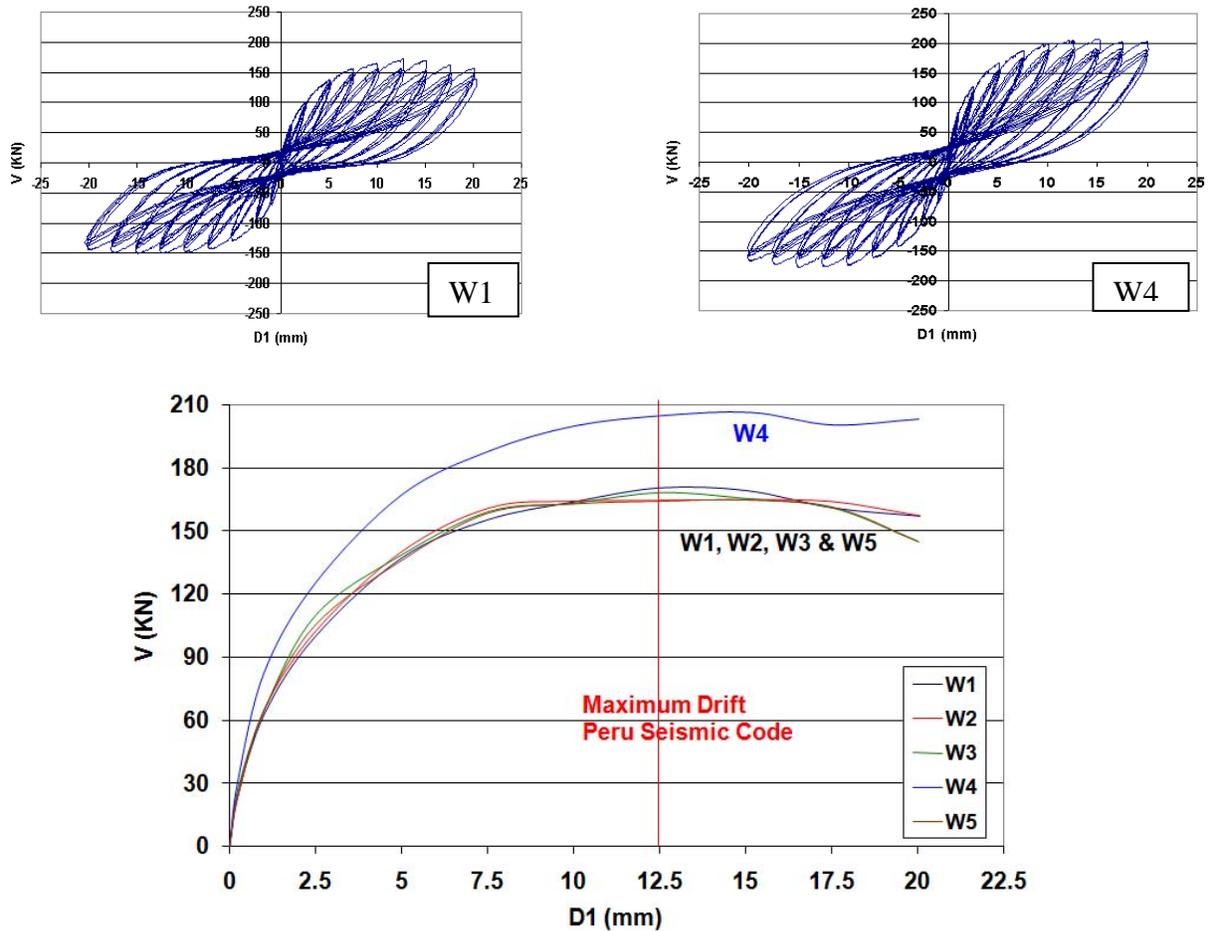
Figure 11: Hysteretic curves and envelopes

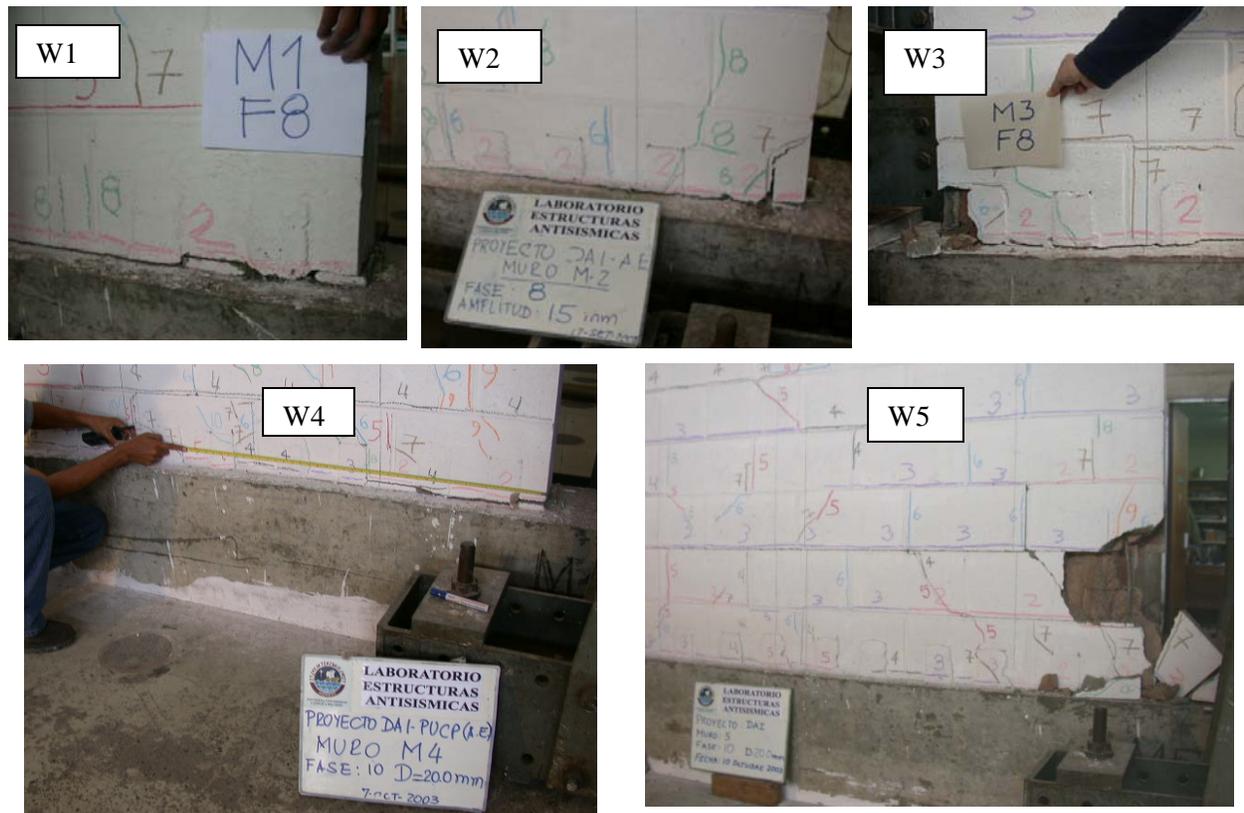
Figure 12: Walls showing sliding failure at different steps of the test, except W4.

In wall W1 two sliding planes were observed: the first one was located at the foundation and was produced during step 5; the second occurred at the fifth layer base, were the dowels end, and was produced during step 7. For walls W2 and W3, the sliding occurred at the foundation during steps 5 and 7, respectively. Wall W4 had no sliding at any step. Finally, wall W5 had sliding at the third layer base, were the dowels end, during step 9. According to the above mentioned criteria, walls W1, W2, W3 are unsafe, while wall W5 could be improved and wall W4 had the best behavior. The added amount of vertical reinforcement in wall W4 appears to have a

significant influence in this behavior. In figure 12, details of the five walls are shown, at the end of step 8 for walls W1, W2 and W3, and at the end of step 10 for walls W4 and W5.

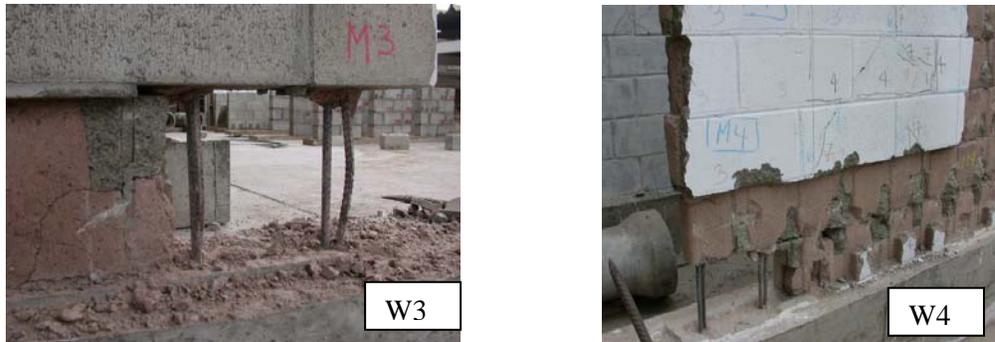
Figure 13: Inspection after the test, buckling of bars at the end of the walls

failure surfaces, which is very dangerous. In walls W2 and W3, the use of overlaps at different heights made that the only sliding surface was the one at the base. In wall W4, the use of dowels of different lengths plus extra dowels at the cells without vertical reinforcement, improved significantly the seismic behavior. A similar conclusion was also reported in reference [4], in which stronger dowel bars were effective to prevent the sliding failure at the bottom of the tested fully grouted masonry wall. Wall W4 had a mixed final failure combined of flexure and shear, with an increased maximum resistance force of 21% respect to wall W1. Furthermore, wall W4 was the only one in which the vertical bars at the wall end did not buckle. In the other four walls buckling of those bars occurred (Figure 13).
