SEISMIC BEHAVIOR OF A TWO STORY MODEL OF CONFINED ADOBE MASONRY

A. San Bartolomé¹, E. Delgado² and D. Quiun³

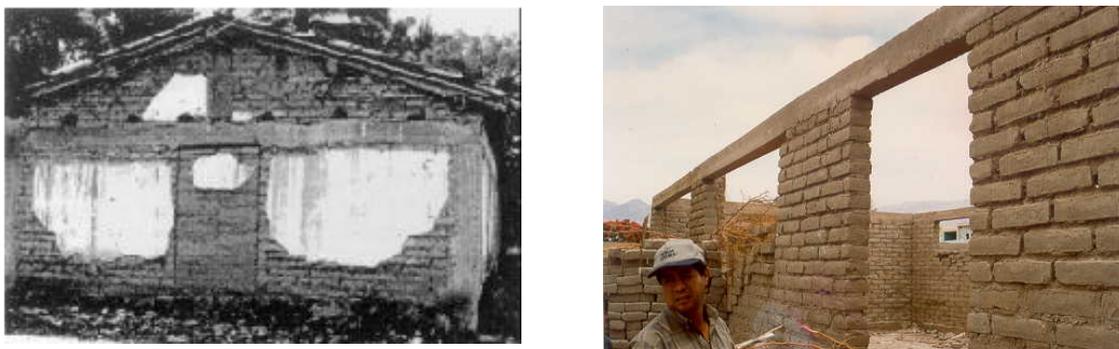
Figure 2: Good behavior of one-story adobe houses confined by RC elements, Ometepec Mexico [4] (left) and Nasca Peru [5] (right)

The Peruvian Adobe Code of 2000 [3] allows the use of reinforced concrete elements, which in one-story houses have shown good earthquake behavior. Reports on the Ometepec, Mexico 1995 $M_s=7.2$ earthquake [4], and the Nazca, Peru 1996, $M=7.5$ earthquake [5] include comments on such observations (Figure 2). Therefore, the objective of this project was to determine if the proposed reinforcement for two-story houses has good behavior and/or drawbacks.

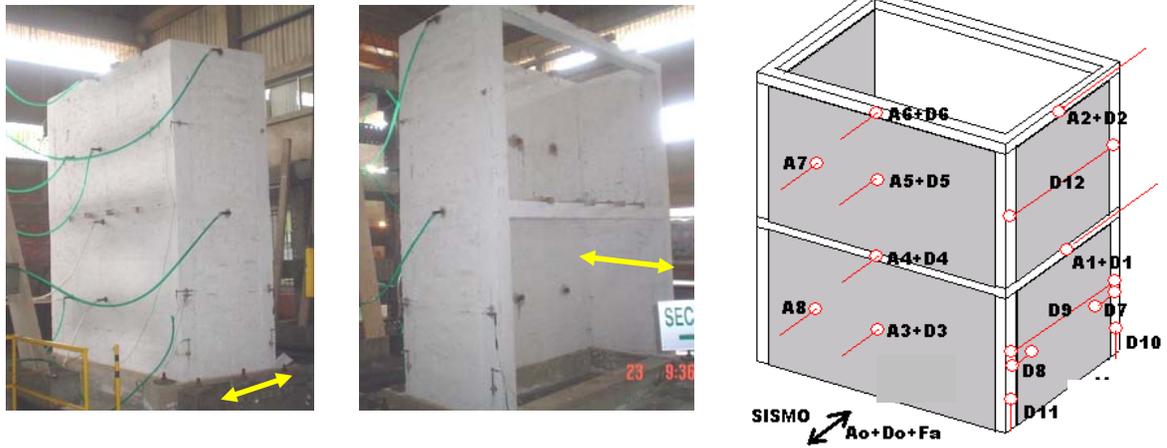
Figure 7: Global view of the specimen and instruments

The instruments used in the test, shown in figure 7, were 9 accelerometers (Ai) and 13 displacement transducers LVDT (Di). Accelerometers A1 and A2 and LVDTs D1 and D2 were located on the first and second story of one wall parallel to the movement. Accelerometers A3 through A8 and LVDTs D3 through D6 were located on the wall and beams perpendicular to the movement. D7 and D8 recorded relative displacements between the concrete columns and adobe walls, D9 and D12 recorded the cracks at the mid height of each story, and D10 and D11 recorded vertical relative displacements between the foundation and concrete columns. The table platform movement is also measured by accelerometer A₀ and LVDT D₀.

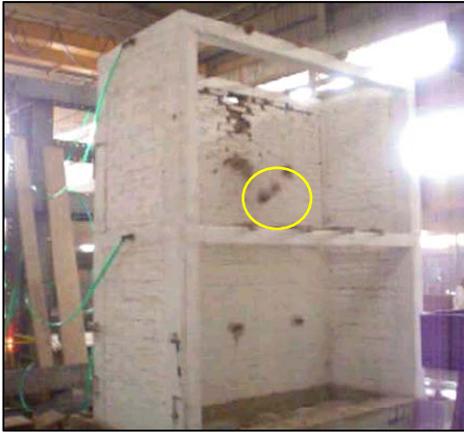
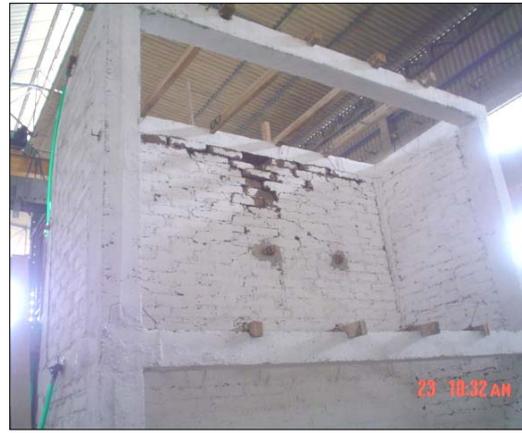
Figure 9: Specimen during step 3 (left) and after step 3 (right).

At the end of step 3, one unit of the upper layer of the second story flexure wall fell down, and it could be seen that this wall was near collapse (Figure 9). The stair-step shear cracks in the shear walls were amplified. Also, some vertical cracks appeared at the first story column-beam connection. It must be mentioned that no cracks appeared in the first story flexure wall.

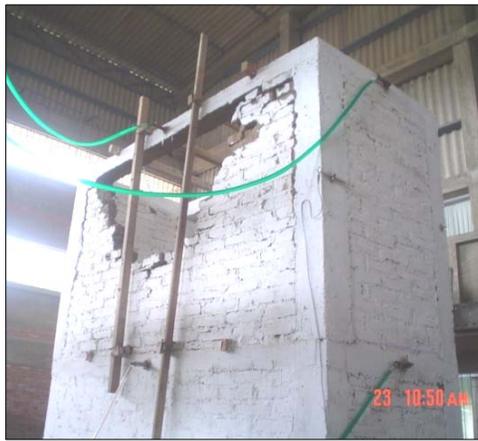
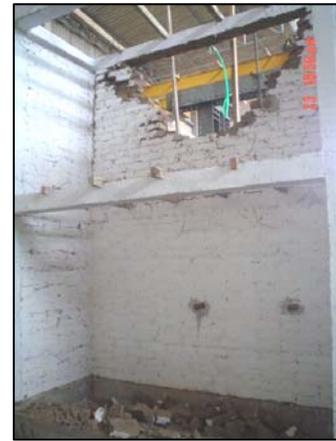
Figure 10: Specimen during step 4 (left) and after step 4 (center and right).

During step 4, the central triangular part of the second story flexure wall collapsed (Figure 10). The shear cracks continued increasing their width, but the adobe units were not crushed. The first story flexure wall remained without cracks.
