## SEISMIC BEHAVIOUR OF ADOBE HOUSES IN PISCO, PERU EARTHQUAKE

A. San Bartolomé<sup>1</sup> and D. Quiun<sup>1</sup>

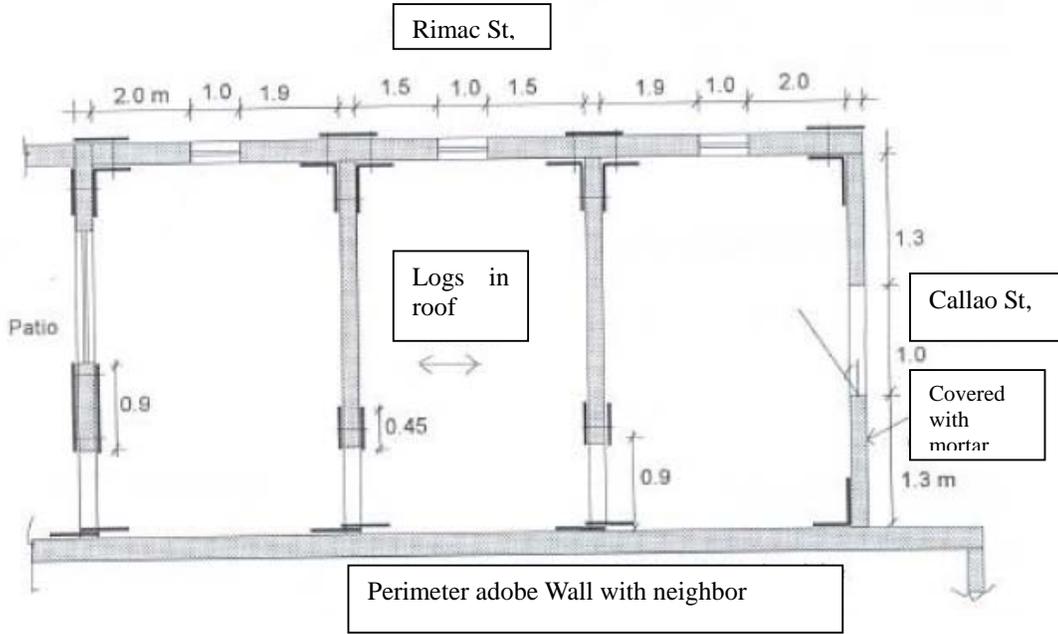
Figure 2. Adobe house in Guadalupe with location of vertical strips.

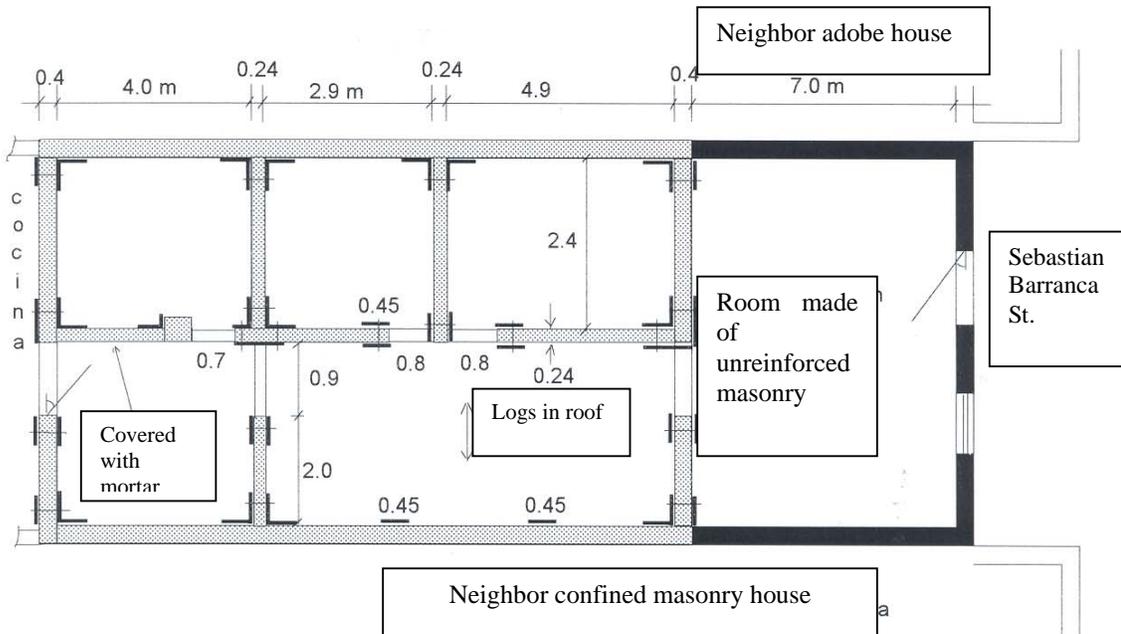
Figure 3. Adobe house in Pachacutec with location of vertical strips.

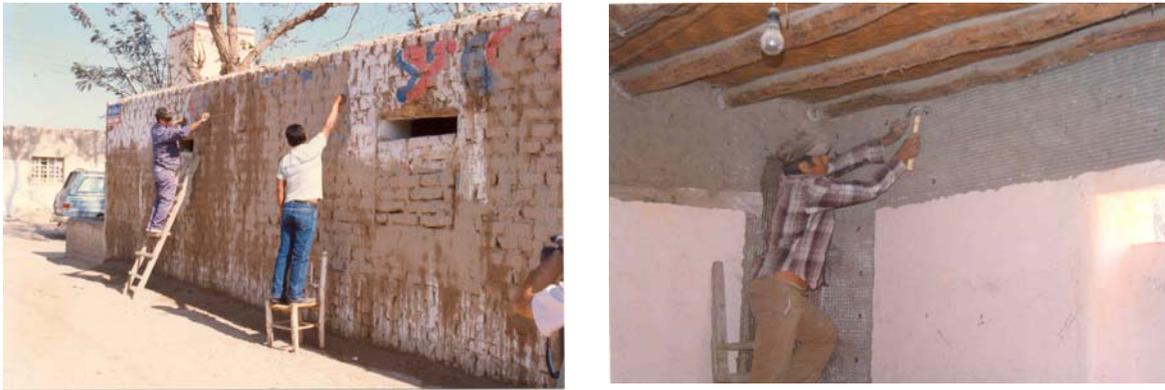
Figure 4. Adobe house in Guadalupe retrofitted in 1998 (left to right): marking horizontal strip at outside wall, nailing horizontal strip in inner side of wall.

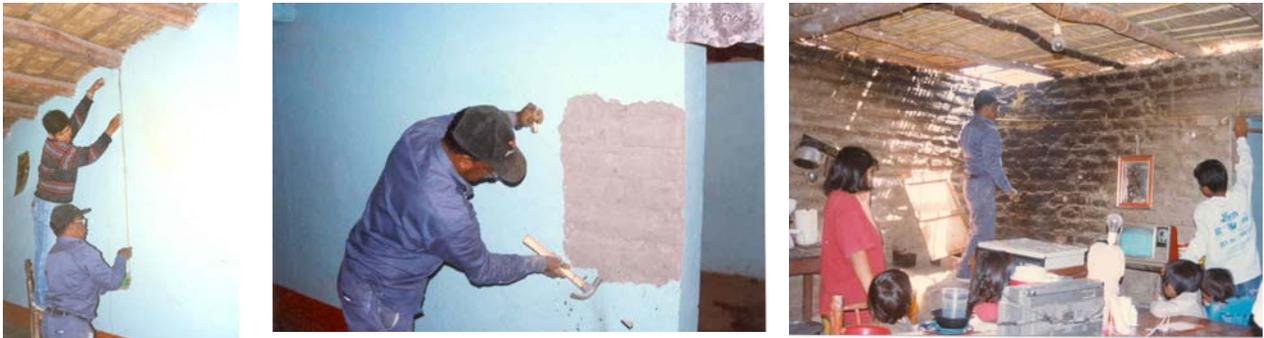
Figure 5. Adobe house in Pachacutec retrofitted in 1998 (left to right): marking vertical strip, removing existing covering, and marking horizontal strip.

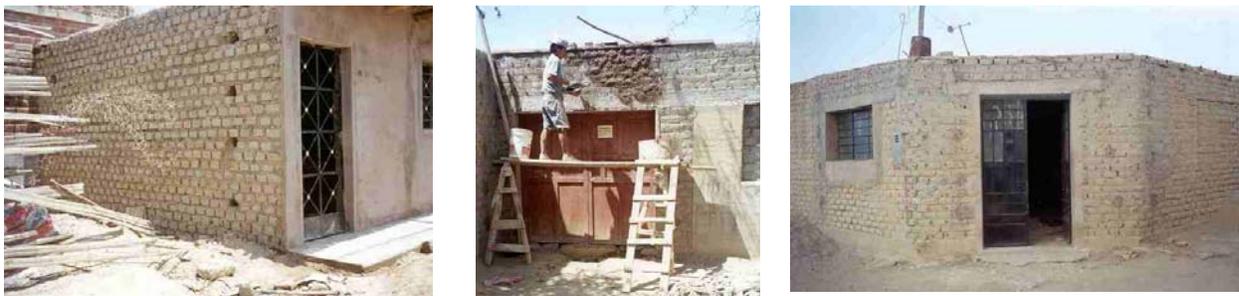
Figure 6. Demonstration adobe houses in (left to right) Ica Central, Parcona and La Tinguina, during reinforcement in 1998.
